# TECHNICAL SERVICE BULLETIN

## 3.0L / 6.7L - Illuminated MIL With Various Reductant System Related DTCs

**21-2336**  
27 September  
2021

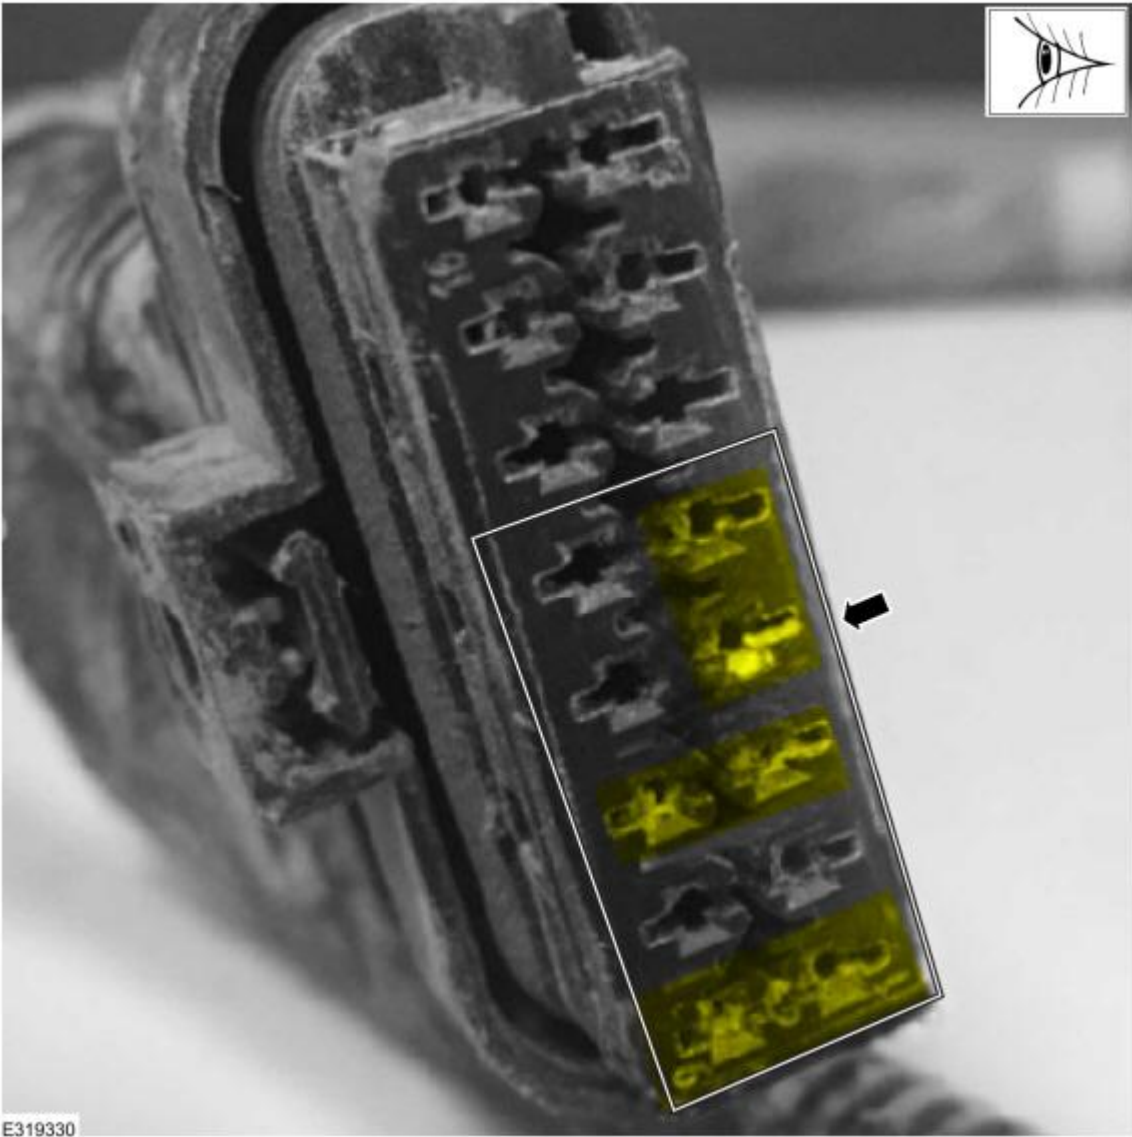
Figure 1

- Visible green corrosion on multiple terminals on the harness side of connector C3613. (Figure 1)

- If there is corrosion or discoloration on the reductant tank harness connector only and not on the reductant pump/heater assembly, only replace the reductant tank harness.

- If there are signs of corrosion or discoloration on the reductant pump/heater assembly, replace both the reductant tank harness and the reductant pump/heater assembly. Refer to WSM, Section 303-08.

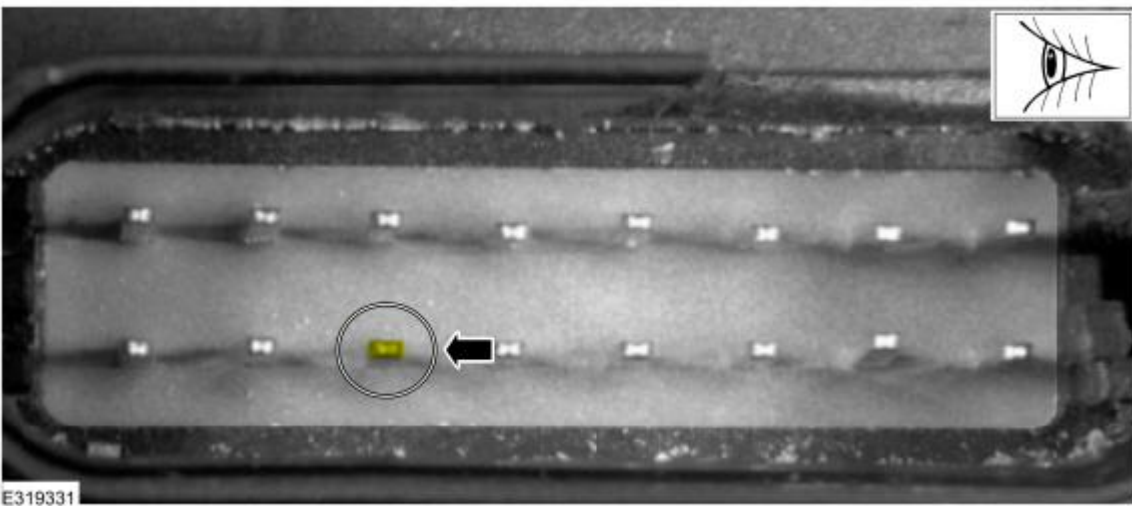
Figure 2

- Corroded pins on the reductant pump/heater assembly at connector C3613. (Figure 2)

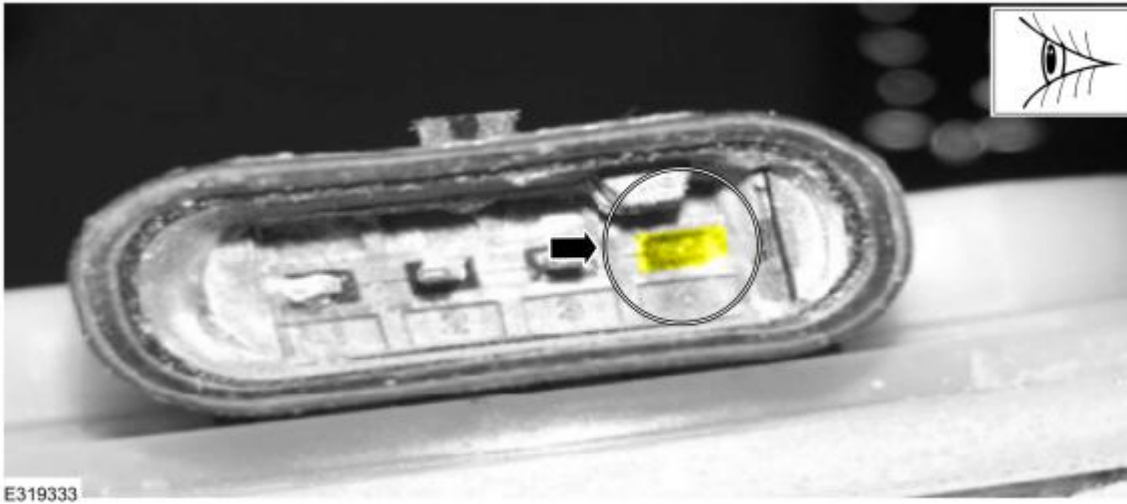
Figure 3

- Visible green corrosion on the reductant level sensor/quality module side of connector C4851/C3610. (Figure 3)

- If there are signs of corrosion or discoloration on the reductant level sensor/quality module, replace both the reductant tank harness and the reductant tank (reductant level sensor/quality module built in).

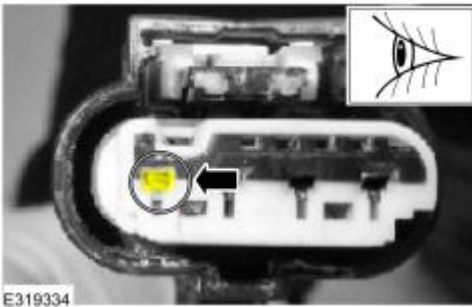
Figure 4

- Visible green corrosion on the harness side of connector C4851/C3610. (Figure 4)

- If there is corrosion or discoloration on the reductant tank harness connector only and not the reductant level sensor/quality module, only replace the reductant tank harness.
