Yellow Breeches Creek Watershed Assessment

Cumberland, York and Adams Counties, Pennsylvania

April 2005

HRG Project No. 0243.180

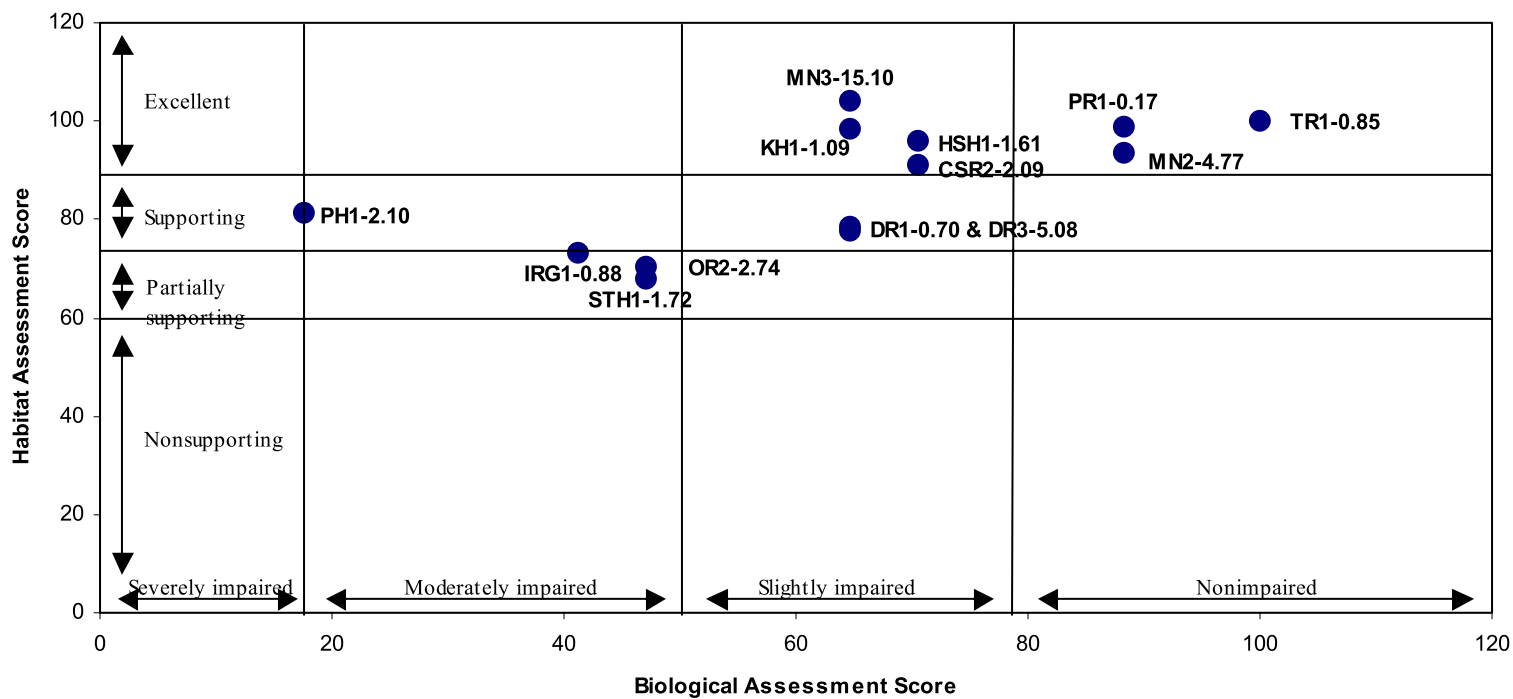
Figure 18. Biological and Habitat Condition Category Determination for High-gradient Tributary Sites

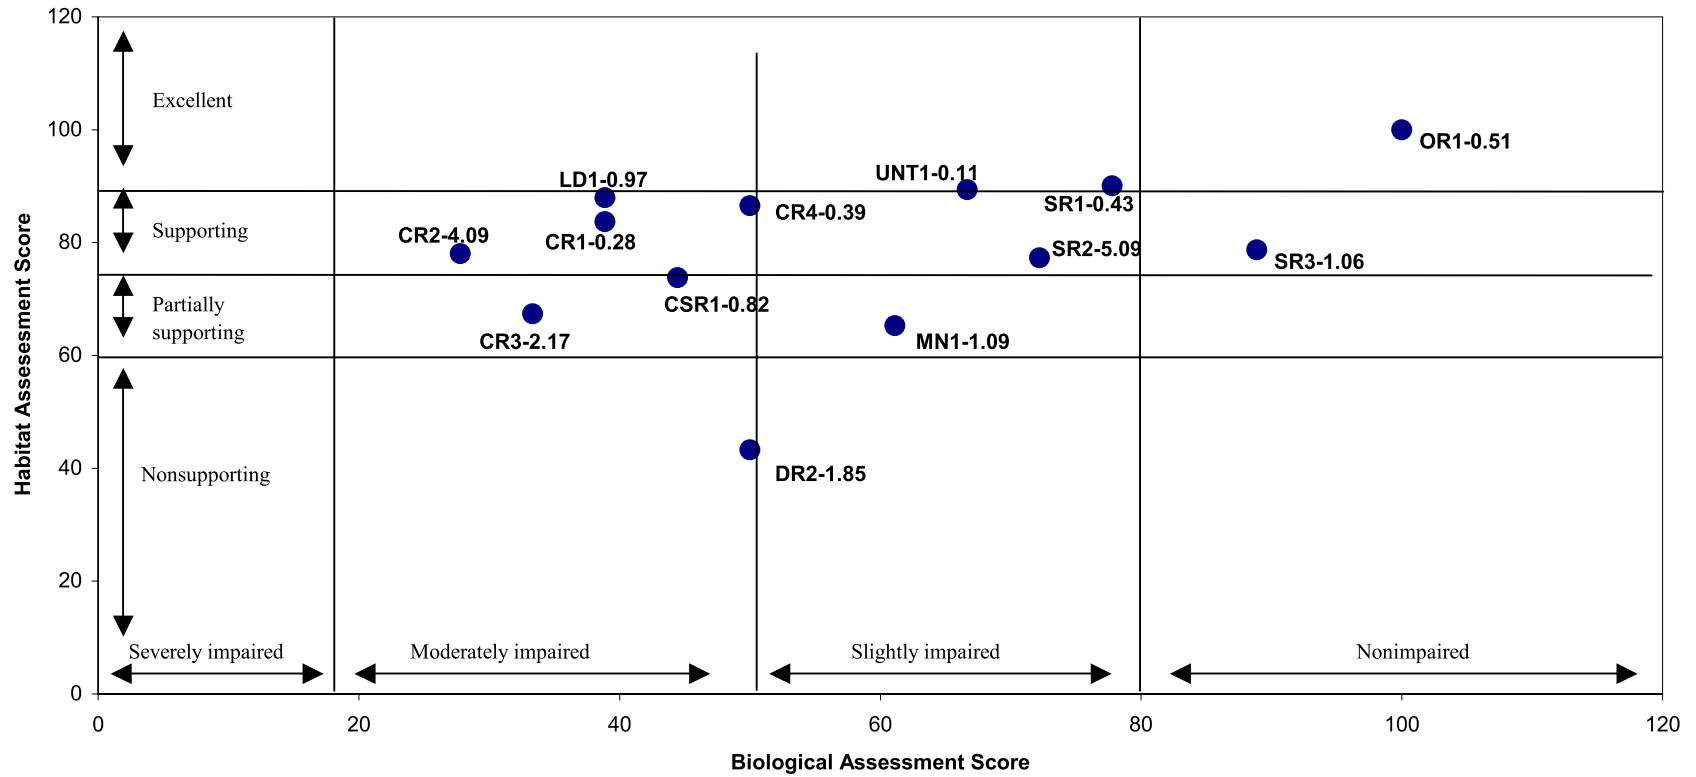
Low-Gradient Tributary Sites - The Habitat Assessment Scores for low-gradient tributary sites range from 43 to 90%, indicating Habitat Condition Categories ranging from nonsupporting to excellent (Table C.9 and Figure C.19). Biological Assessment Scores range from 28 to 89%, indicating Biological Condition Categories ranging from moderate impairment to nonimpairment. One site other than the reference site had excellent habitat, but with a slightly impaired community (SR1-0.43). Eight (8) sites had supporting habitat, one with a nonimpaired biological community (SR3-1.06), two (2) with slightly impaired communities (SR2-5.09 and UNT1-0.11), and four (4) with moderately impaired communities (CR1-0.28, CR2-4.09, CR4-0.39, and LD1-0.97). Three (3) sites had partially supporting habitat, one with a slightly impaired community (MN1-1.09), and two (2) with moderately impaired communities (CR3-2.17 and CSR1-0.82). One site had nonsupporting habitat and a moderately impaired biological community (DR2-1.85).

Figure 19. Biological and Habitat Condition Category Determination for Low-gradient Tributary Sites

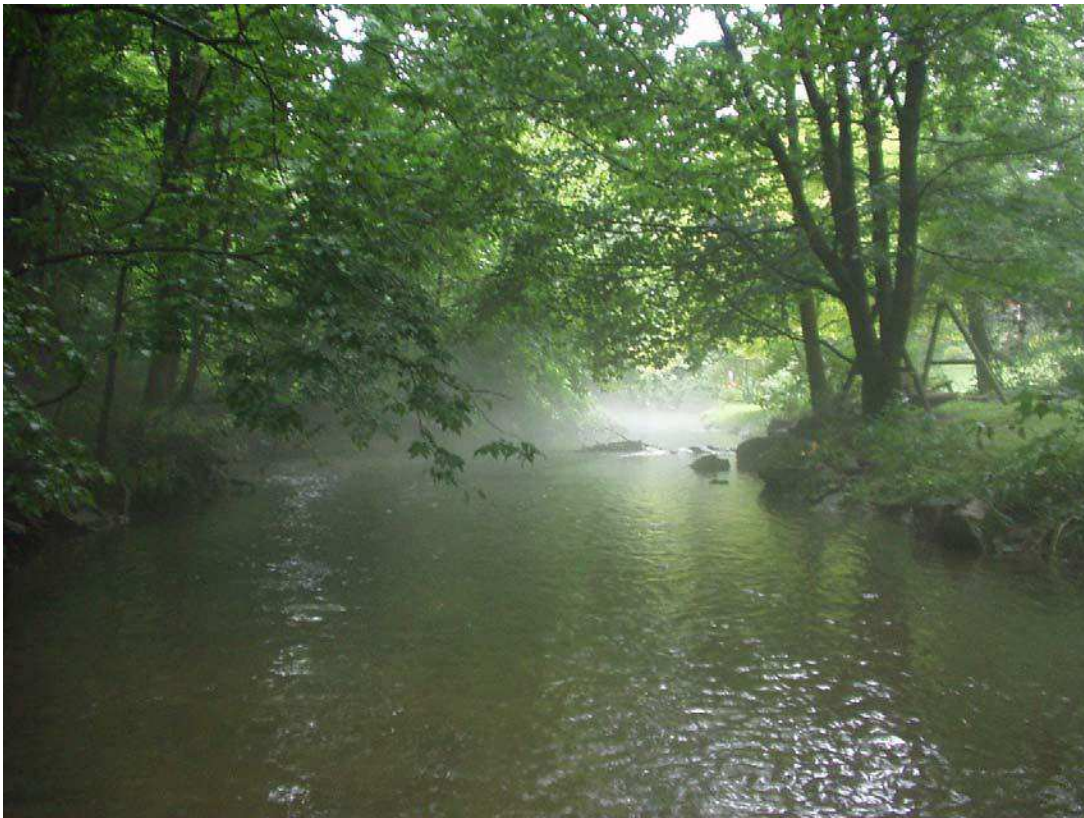
Photo C.1 Cedar Run (CR1-0.28)

CR1-0.28 was located approximately 60 meters upstream of the 17th Street Bridge crossing in Camp Hill, PA, which is the same location of a USGS National Water Quality Assessment (NAWQA) study site. Residential development, managed lawn, and occasional trees are located along the left bank. The left bank was marginally stable and exhibited undercutting. The right bank is steep, with suboptimal stability, and consists of a woody riparian buffer of approximately 12-18 meters. Moderate sediment deposition was noted near the top of the reach. Substrate was suboptimal and dominated by cobble and sand. Snags, submerged macrophytes, vegetated banks, and gravel were also present. The stream at this site was approximately 15 meters in width, 0.35 meters in depth, and was largely dominated by run. Data analysis indicated that CR1-0.28 had supporting habitat and a moderately impaired benthic macroinvertebrate community. See Photo C.1.

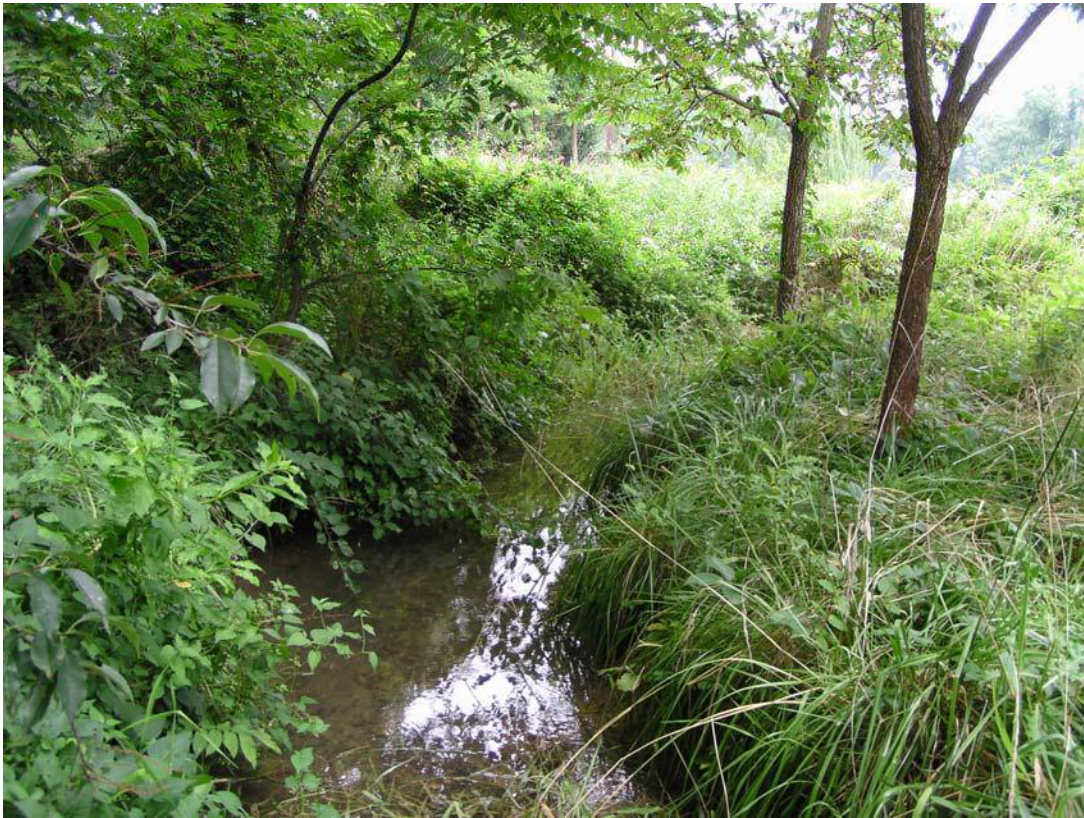
Photo C.2 Cedar Run (CR2-4.09)

CR2-4.09 was located approximately 60 meters upstream of the Rossmoyne Road crossing. Land use in the vicinity consisted of active and fallowed agriculture and residential. The left bank riparian zone consisted of a mix of lawn, shrubs, trees, and emergent wetland plant species and exhibited a moderately stable bank. The right bank was dominated by managed lawn to the edge of water, yet stability was also moderate. Moderate sediment deposition was noted in select locations of the reach. Substrate was suboptimal and dominated by cobble, submerged macrophytes, and vegetated banks. The stream at this site was approximately 1 meter in width, 0.10 meters in depth, and consisted entirely of run. Data analysis indicated that CR2-4.09 had supporting habitat and a moderately impaired benthic macroinvertebrate community. See Photo C.2.

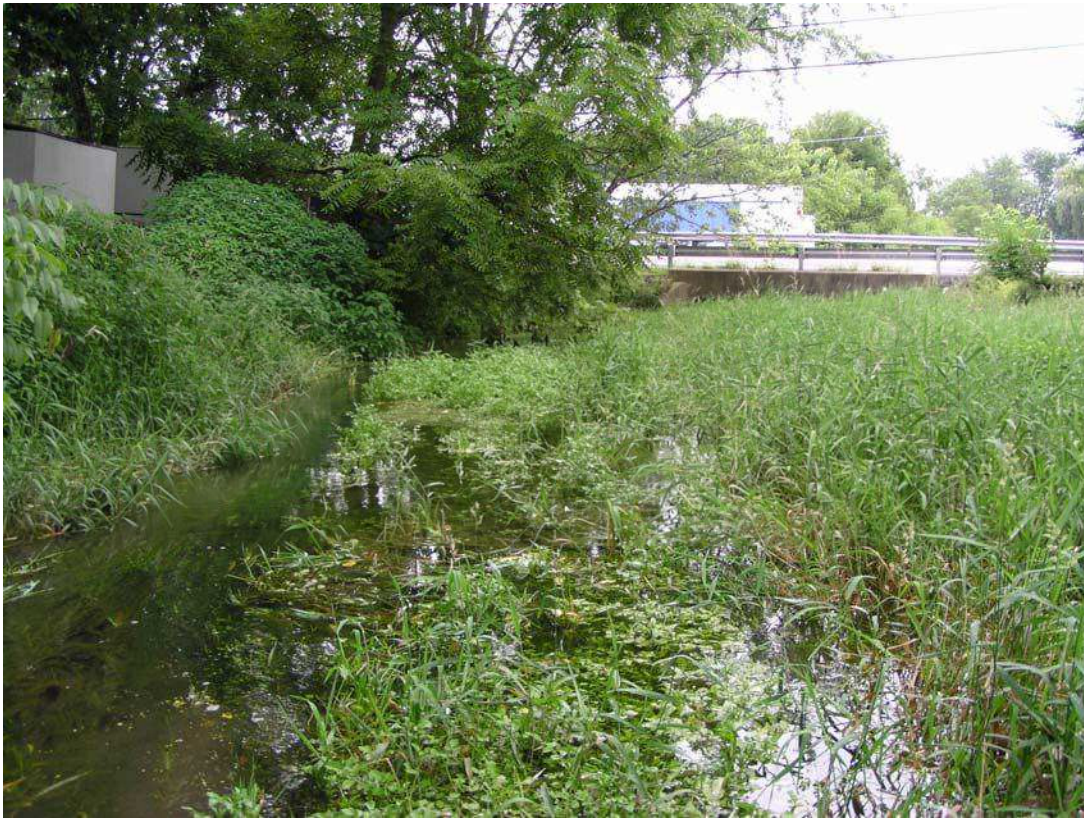
Photo C.3 Cedar Run (CR3-2.17)

CR3-2.17 was located approximately 60 meters upstream of the Hartzdale Drive crossing. A trailer park was located along the left bank, and industrial land use was located along the right bank. Riparian zone width on both banks was poor due to human activities up to the edge of water, including evidence of debris dumping on the left bank. Bank stability along the site was marginal to suboptimal, with instability evident in several locations. Sediment deposition was significant throughout the reach. This site was dominated by a heavy abundance of submerged macrophytes and periphyton. Substrate was marginal. The stream at this site was approximately 8 meters in width, 0.33 meters in depth, and consisted entirely of run. Data analysis indicated that CR3-2.17 had partially supporting habitat and a moderately impaired benthic macroinvertebrate community. See Photo C.3.

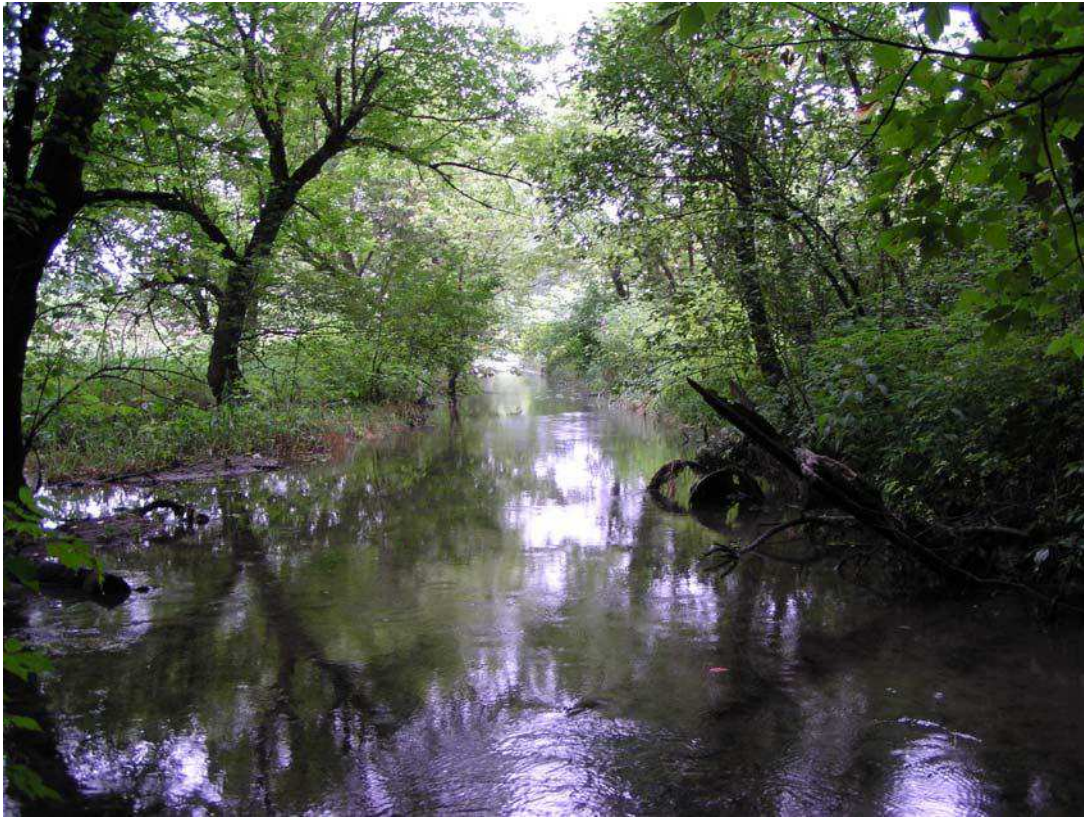
Photo C.4 Cedar Run (CR4-0.39)

CR4-0.39 was located approximately 60 meters downstream of the Hartzdale Drive crossing adjacent to Theo's Restaurant. Both the left and right bank riparian zones were 12 to greater than 18 meters in width and showed minimal signs of disturbance. Bank stability was moderate, with small and infrequent areas of erosion. Sediment deposition was present in the pool section of the reach, but was not excessive. Substrate was marginal and dominated by cobble, sand, and submerged macrophytes. Stream sediments had the odor of volatile organic carbons (VOCs), specifically gasoline. Tadpoles and blacknose dace were abundant in the pool. The stream at this site was estimated to be approximately 0.5 meters in width, 0.15 meters in depth, and consisted of an even distribution of riffle and run. Data analysis indicated that CR4-0.39 had supporting habitat and a moderately impaired benthic macroinvertebrate community. See Photo C.4.

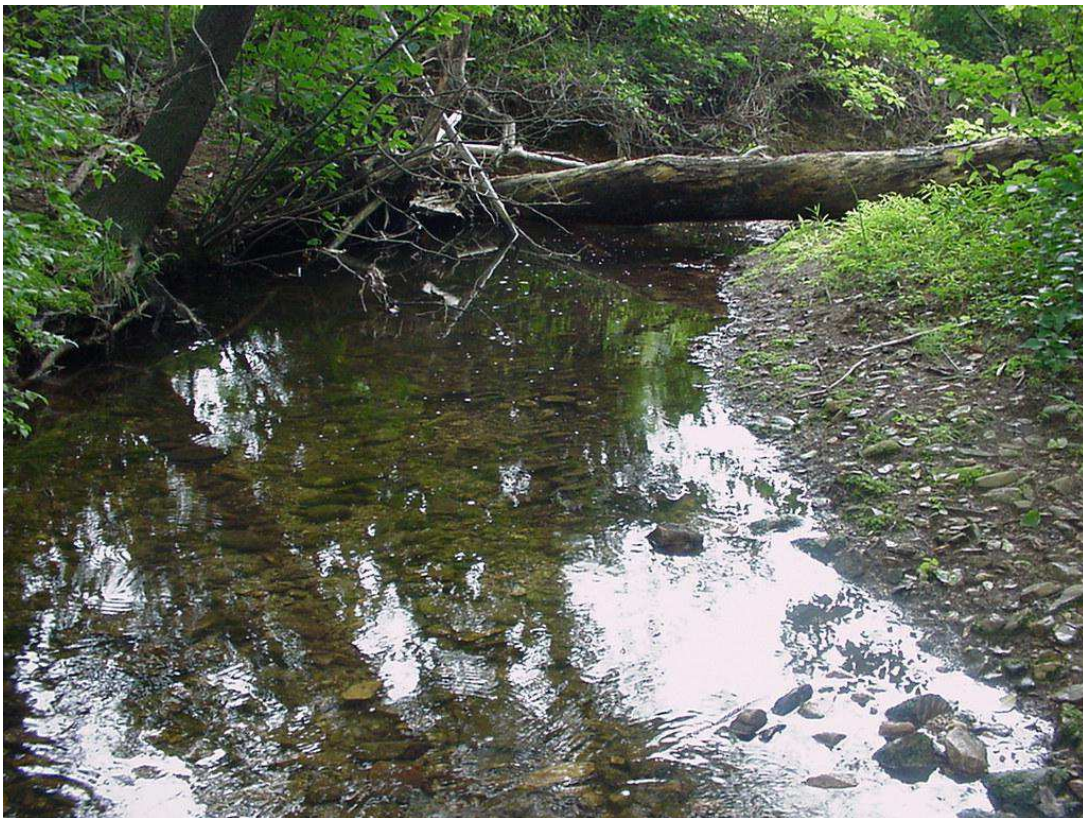
Photo C.5 Cold Spring Run (CSR1-0.82)

CSR1-0.82 was located approximately 30 meters upstream of the Pine Road crossing, which is near Yellow Breeches Road. Land use along this reach was dominated by active row crops on the left bank and forest and Pine Road on the right bank. As such, riparian width for the right bank was poor and only marginal for the left bank. Bank stability was marginal for the left bank as erosion was present and suboptimal for the right bank due to the forested area. Moderate sediment deposition was evident, especially in the pool portions of the reach. Substrate was optimal and dominated by cobble and root wads with occasional snags and submerged macrophytes. The stream at this site was approximately 1.5 meters in width, 0.10 meters in depth, and consisted of an even distribution of riffle and run. Data analysis indicated that CSR1-0.82 had partially supporting habitat and a moderately impaired benthic macroinvertebrate community. See Photo C.5.

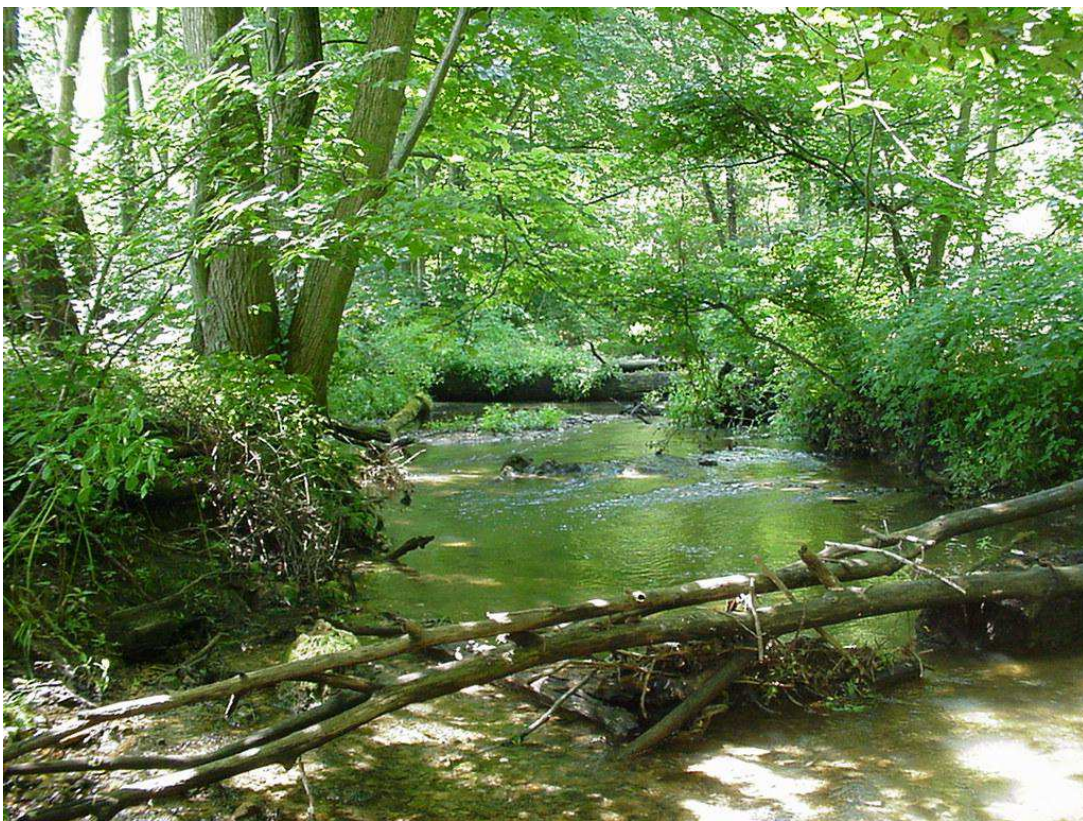
Photo C.7 Dogwood Run (DR1-0.70)

DR1-0.70 was set approximately 40 meters upstream of its confluence with the Yellow Breeches Creek. While the majority of the surrounding land use was forest, significant clearing was observed on the right bank approximately 20 meters from the edge of water. The left bank was moderately more stable than the right bank. Sediment deposition was moderate throughout the reach. Substrate was optimal and dominated by cobble, woody debris, and root wads. The stream at this site was approximately 2 meters in width, 0.20 meters in depth, and was dominated by riffle, run, and pool. Data analysis indicated that DR1-0.70 had supporting habitat and a slightly impaired benthic macroinvertebrate community. See Photo C.7.

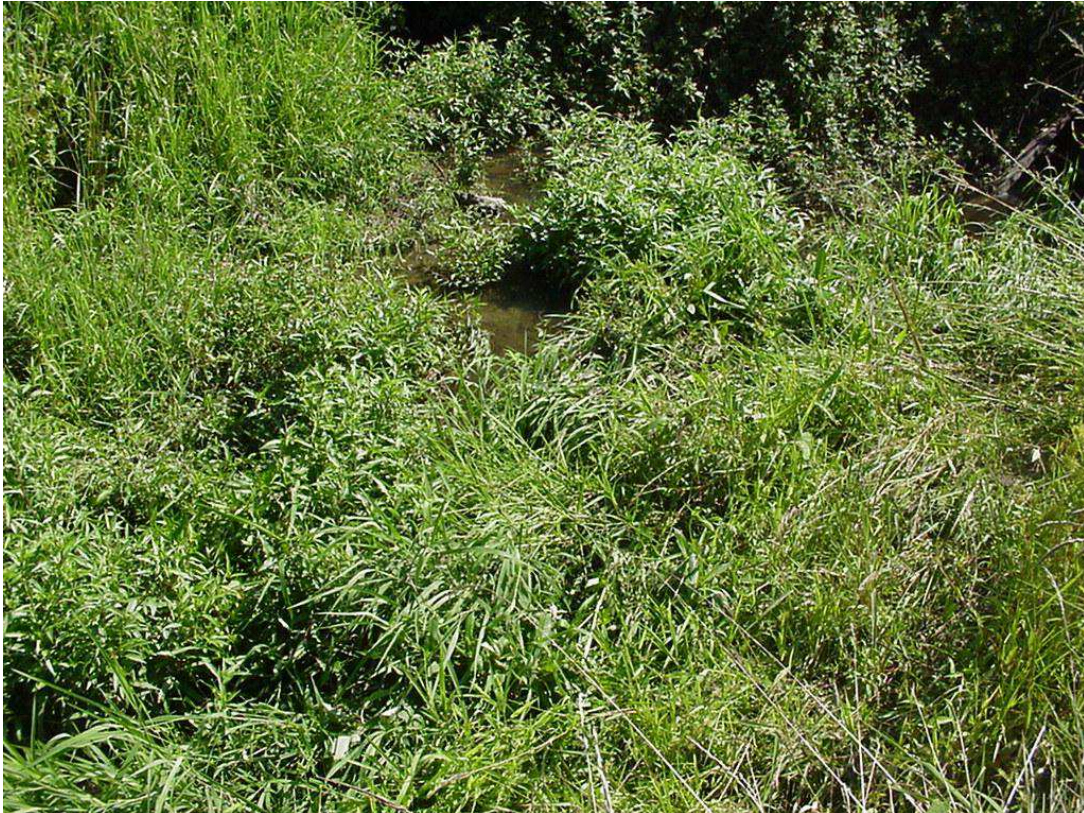
Photo C.8 Dogwood Run (DR2-1.85)

DR2-1.85 was situated approximately 30 meters downstream of the Rt. 74 crossing. Followed agricultural land was located along the right bank. While residential land use was located along the left bank, approximately 15 feet of undisturbed and native vegetation separated the left edge of water from the managed residential lawn. Sediment deposition was significant throughout and bank stabilities were poor. Substrate was poor and consisted of cobble, vegetated banks, and muck. Tadpoles and blacknose dace were abundant. The stream at this location was approximately 2 meters in width, 0.1 meters in depth, and consisted entirely of run. Data analysis indicated that DR2-1.85 had no supporting habitat and had a moderately impaired benthic macroinvertebrate community. See Photo C.8.

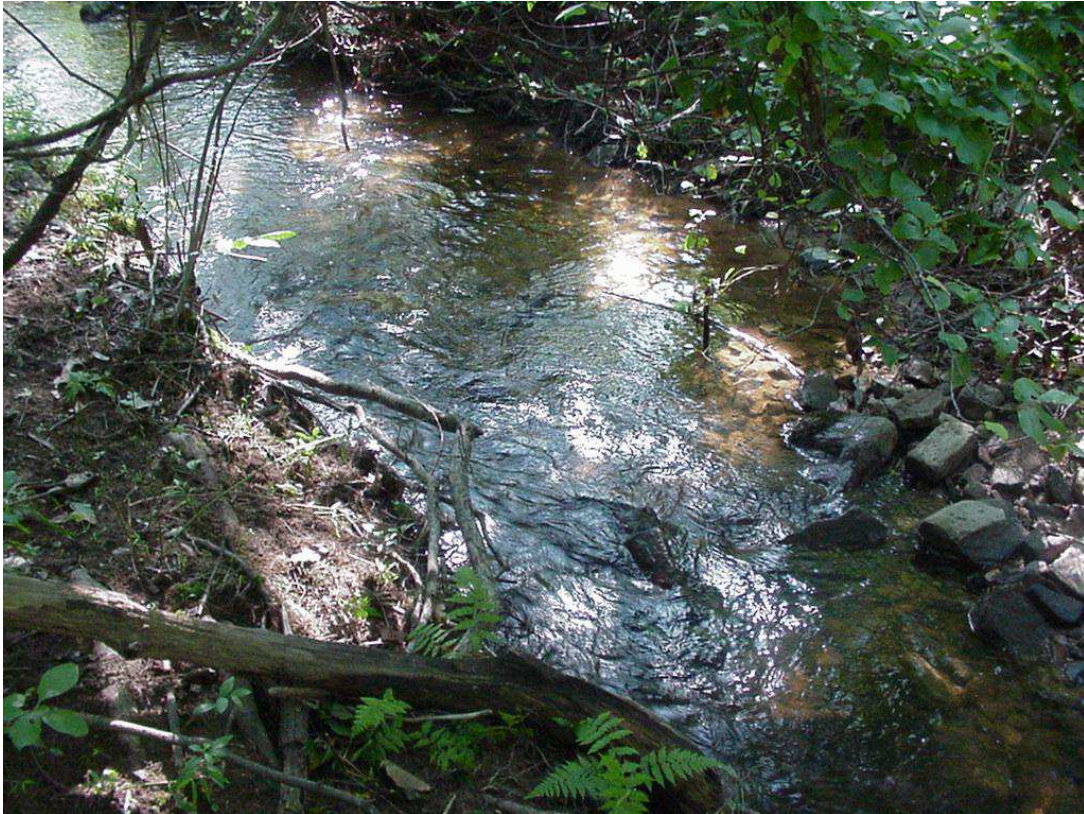
Photo C.9 Dogwood Run (DR3-5.08)

DR3-5.08 was located 30 meters upstream of the Green Road crossing. The surrounding land use consisted of undisturbed forest and was represented by a good-quality riparian zone. However, bank stability was poor because of frequent and unstable areas. Undercut banks and sandbar formation were observed throughout the reach, particularly in meanders. Sediment deposition was moderate. Substrate was suboptimal and dominated by cobble. The stream at this site was approximately 2 meters in width and 0.25 meters in depth. Data analysis indicated that DR3-5.08 had supporting habitat and a slightly impaired benthic macroinvertebrate community. See Photo C.9.

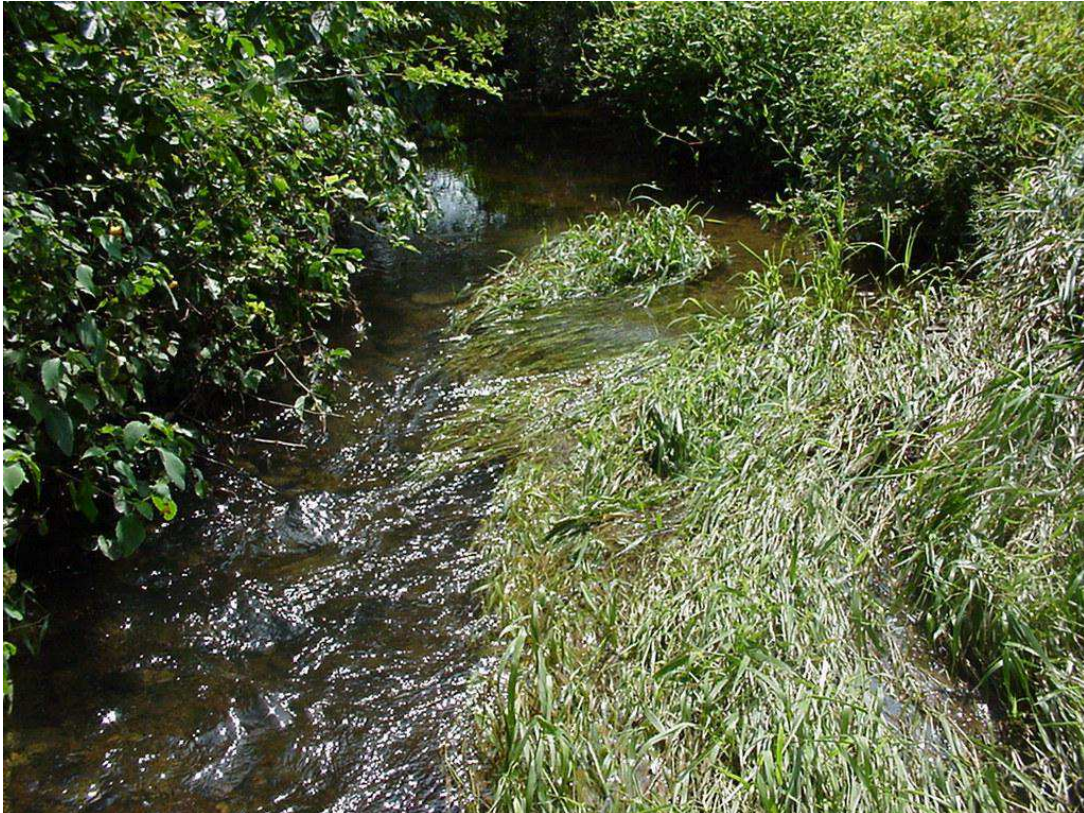
Photo C.10 Fishers Run (SR3-1.06)

Fishers Run - The site SR3-1.06 was classified as low-gradient and was originally thought to be located on Stony Run. After sampling, however, SR3-1.06 was determined to be located on Fishers Run, a tributary to Stony Run. SR3-1.06 was located approximately 30 meters upstream of Filey's Road crossing. Surrounding land use consisted of field and pasture. Herbaceous vegetation dominated the riparian zones, which were significantly impacted. Bank stability and sediment deposition were marginal. Substrate was also marginal and was dominated by cobble. The stream at this site was approximately 1.5 meters in width and 0.25 meters in depth. Data analysis indicated that SR3-1.06 had supporting habitat and a nonimpaired benthic macroinvertebrate community. See Photo C.10.

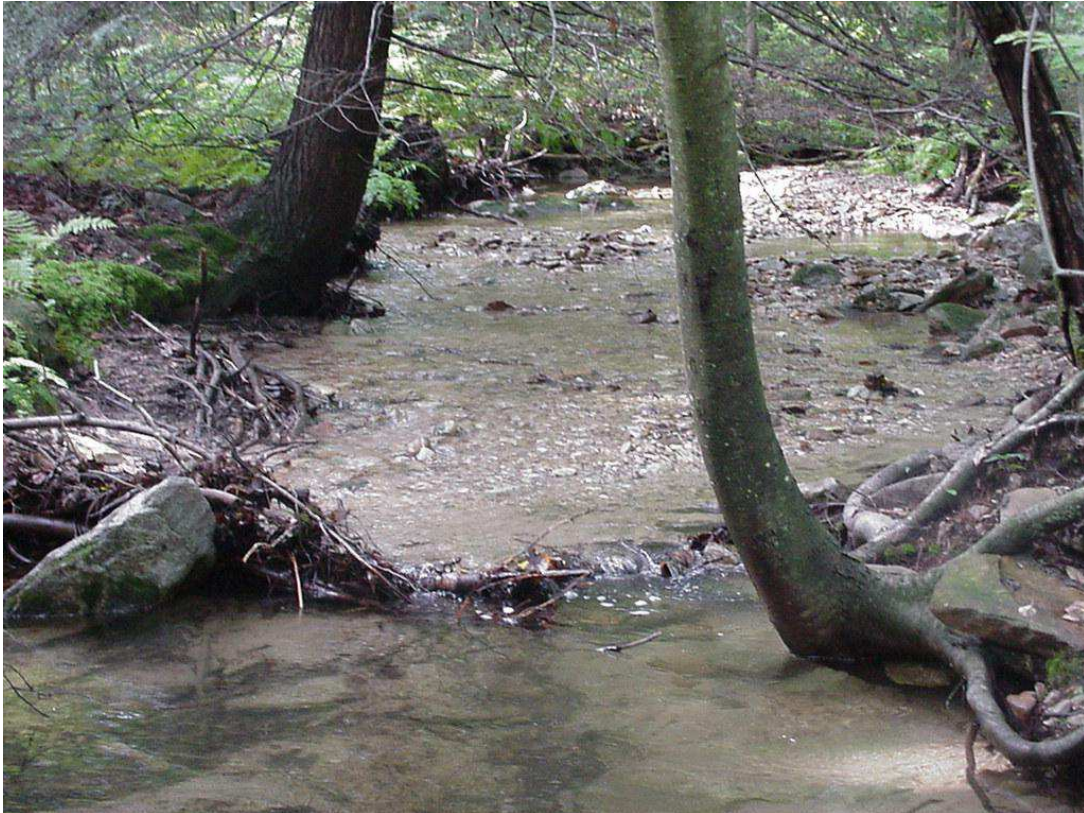
Photo C.11 Hairy Spring Hollow (HSH1-1.61)

Hairy Spring Hollow - One site was chosen on Hairy Spring Hollow (HSH1-1.61) and was classified as high-gradient. HSH1-1.61 was located approximately 30 meters upstream of Furnace Hollow Road. Surrounding land use consisted largely of undisturbed forest, and riparian zone widths for both banks were suboptimal to optimal. Bank stability was moderate with infrequent areas of erosion. Little or no evidence of sediment deposition was observed. Substrate was optimal and consisted of cobble, root wads, and snags. The stream at this site was approximately 7.5 meters in width and 0.3 meters in depth. Data analysis indicated that HSH1-1.61 had excellent habitat and a slightly impaired benthic macroinvertebrate community. See Photo C.11.

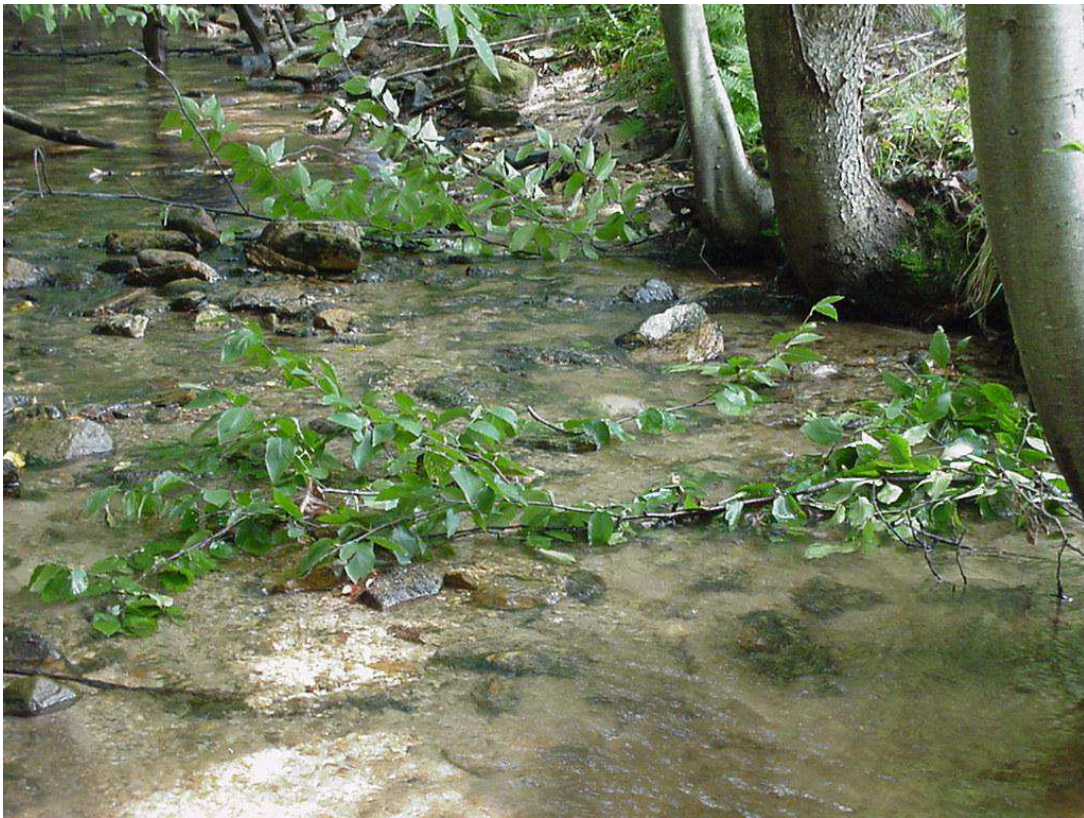
Photo C.12 Irishtown Gap Hollow (IG1-0.88)

Irishtown Gap Hollow - One site was chosen on Irishtown Gap Hollow (IG1-0.88) and was classified as high-gradient. IG1-0.88 was located approximately 400 meters upstream of the Leeds Road crossing, parallel with Irishtown Gap Road. Residential land use and managed lawn was located along the left bank to the edge of water, whereas the right bank consisted of forest. Sediment deposition was moderate. Substrate components were dominated by cobble, sand, and gravel. Approximately 5% of the reach consisted of organic substrate of woody debris. The stream at this site was approximately 2 meters in width and 0.2 meters in depth. Local residents indicated that the stream has not gone dry in recent memory and rises only approximately one meter during high precipitation. Data analysis indicated that IG1-0.88 had partially supporting habitat and a moderately impaired benthic macroinvertebrate community. See Photo C.12.

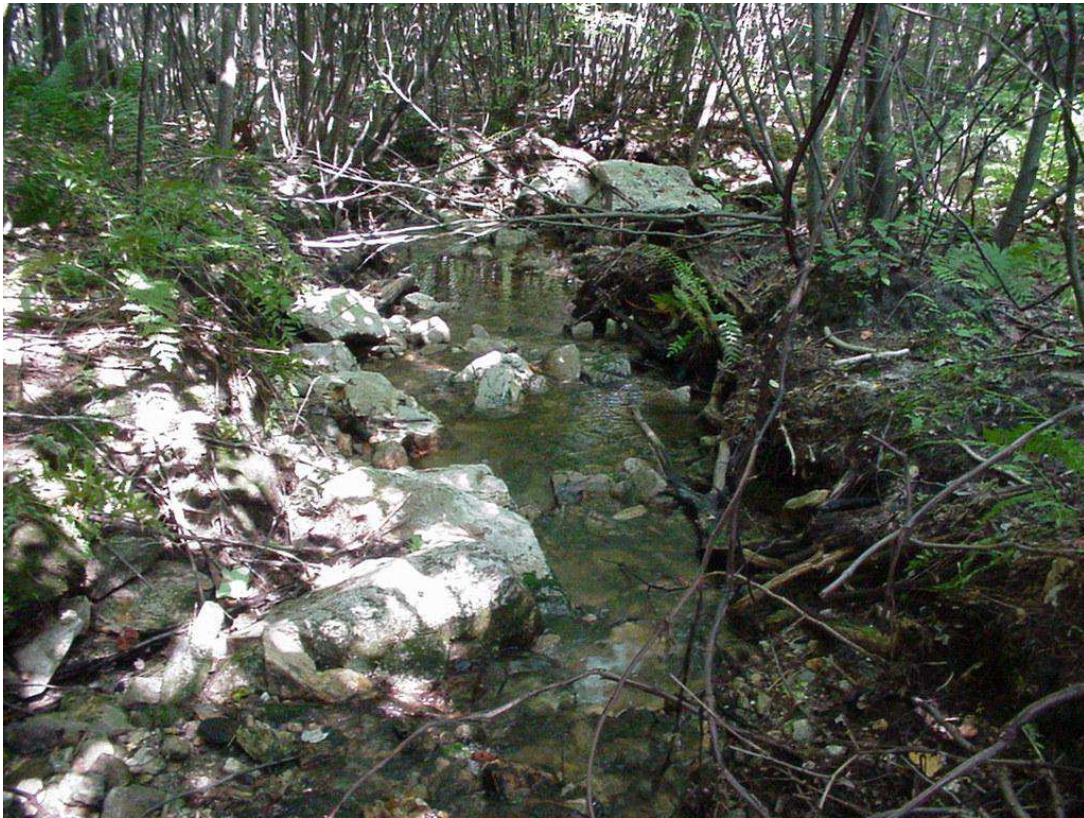
Photo C.13 Kings Gap Hollow (KH1-1.09)

King's Gap Hollow - One site was chosen on King's Gap Hollow (KH1-1.09) and was classified as high-gradient. KH1-1.09 was located 30 meters upstream of the King's Gap Road crossing in the King's Gap State Park. Since the surrounding land use consisted of forest, riparian zones were excellent and undisturbed. Bank stability was also excellent, with little or no evidence of erosion or bank failure. Sediment deposition was evident in some locations, but was dominated by cobble and gravel. Large woody debris was located in several sections of the reach. Substrate was largely dominated by cobble and snags and was optimal. The stream at this site was approximately 2 meters in width and 0.2 meters in depth. Data analysis indicated that KH1-1.09 had excellent habitat and a slightly impaired benthic macroinvertebrate community. See Photo C.13.

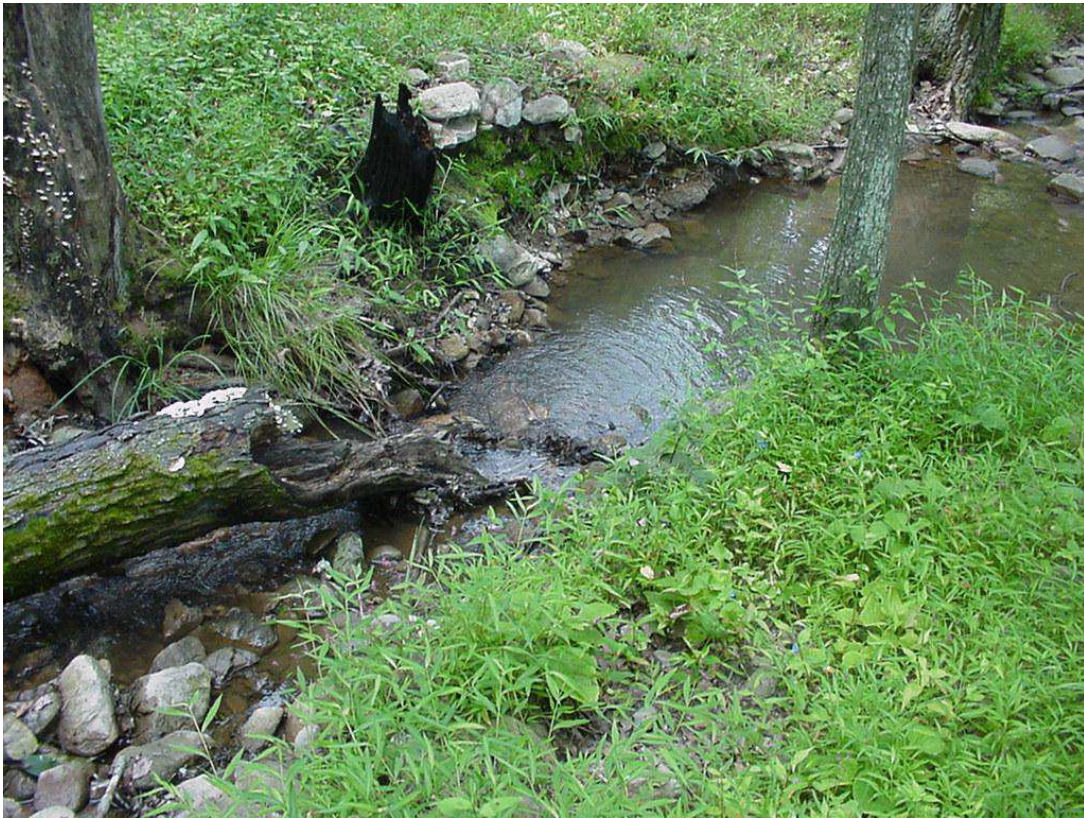
Photo C.14 Little Dogwood Run (LD1-0.97)

Little Dogwood Run - One site was chosen on Little Dogwood Run (LD1-0.97) and was classified as low-gradient. LD1-0.97 was located approximately 30 meters upstream of Wayne Noss Flowers, a private business. The upper half of the reach was dominated by forest, and a mix of pasture and forest was observed along the remainder of the reach. Riparian zones were adequate, but disturbance from the pasture was evident in the lower portions of the reach. Bank stability was suboptimal, as some evidence of erosion was observed along with sediment deposition. Substrate was marginal and dominated by cobble. The stream at this site was approximately 1 meter in width and 0.05 meters in depth. Data analysis indicated that LD1-0.97 had supporting habitat and a moderately impaired benthic macroinvertebrate community. See Photo C.14.

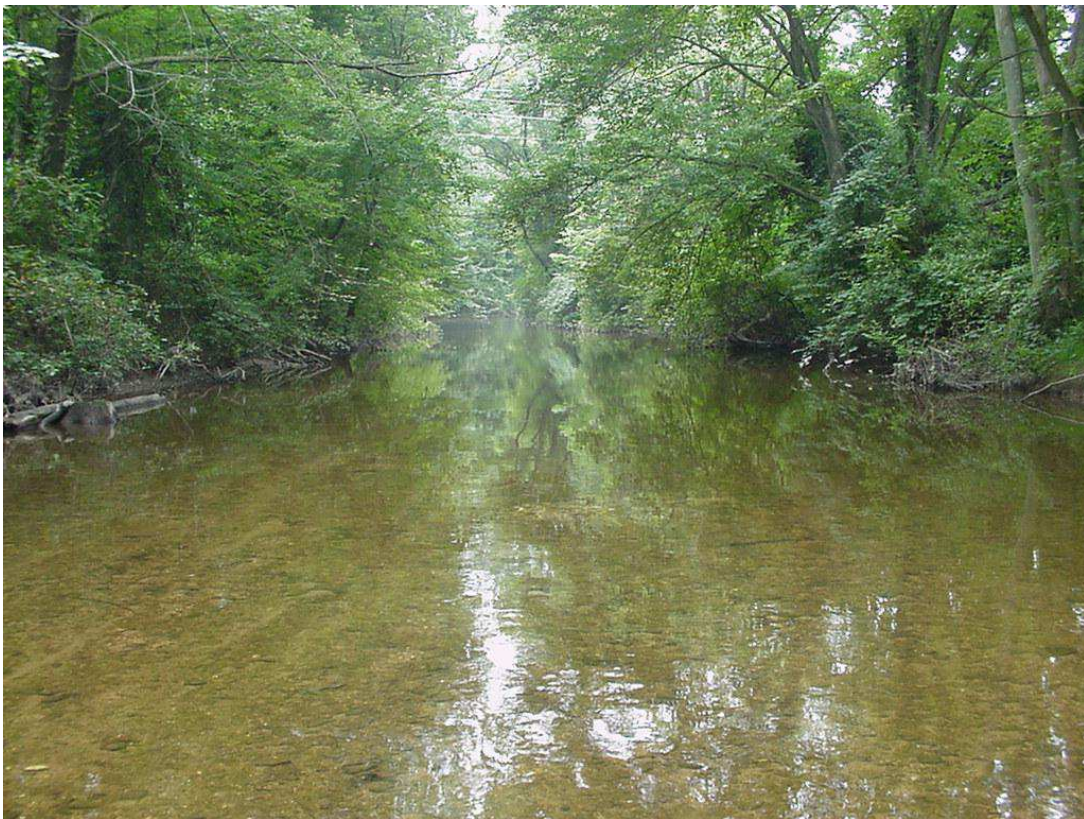
Photo C.15 Mountain Creek (MN1-1.09)

MN1-1.09 was located approximately 150 meters upstream of the confluence with Yellow Breeches Creek in Mount Holly Springs Borough. Land use consisted of a mixture of pasture, cropland, and residential lawn. Consequently, the riparian zone on the left bank exhibited the influence of human activities. Bank stabilities for the reach were suboptimal and with only minor areas of erosion evident. Sediment deposition, however, was quite evident throughout the reach. Substrate was marginal and consisted of cobble, snags, and root wads. The stream at this site was approximately 11 meters in width and 0.2 meters in depth. Data analysis indicated that MN1-1.09 had partially supporting habitat and a slightly impaired benthic macroinvertebrate community. See Photo C.15.

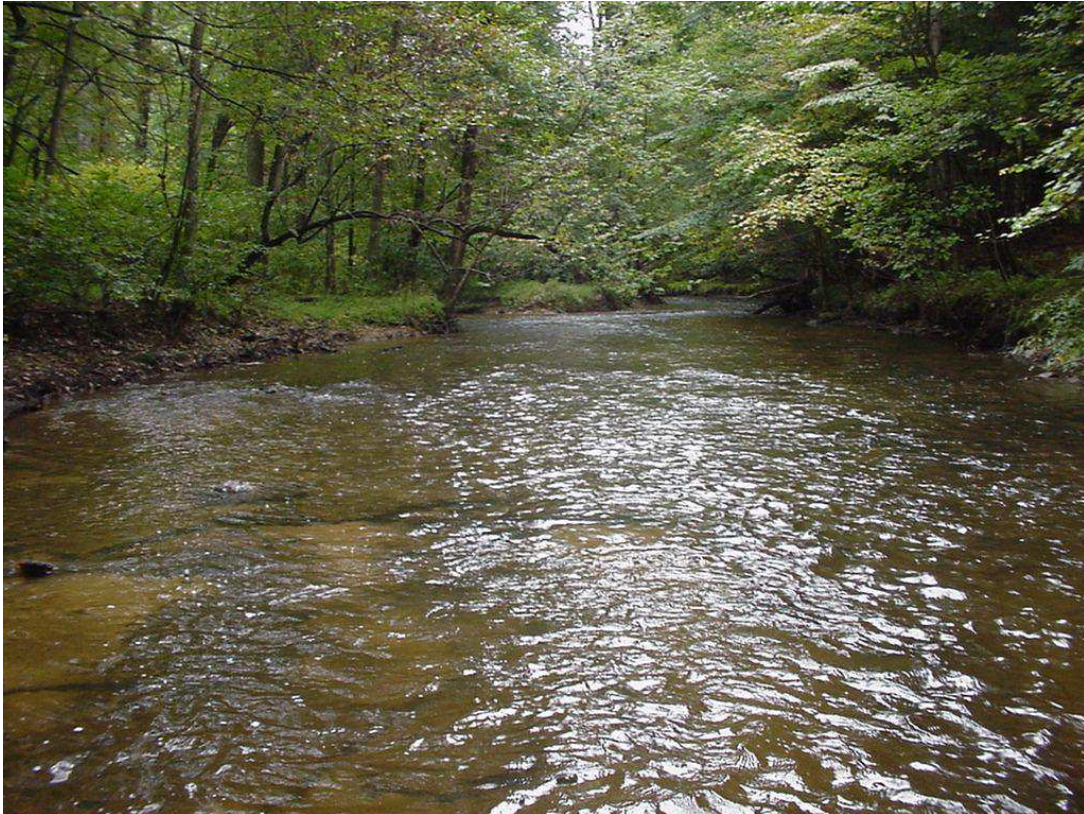
Photo C.16 Mountain Creek (MN2-4.77)

MN2-4.77 was located adjacent to Rt. 34, approximately 3.2 kilometers south of Mount Holly Springs Borough. The site is located in a forested area that is protected by the Nature Conservancy. The left bank was steep, while the right bank expanded into an extensive floodplain. Bank stability varied with the left bank marginally more unstable than the right. Sediment deposition was evident in some locations. Substrate was optimal and dominated by cobble and snags. The stream at this site was approximately 13 meters in width and 0.5 meters in depth. Data analysis indicated that MN2-4.77 had excellent habitat and a slightly impaired benthic macroinvertebrate community. See Photo C.16.

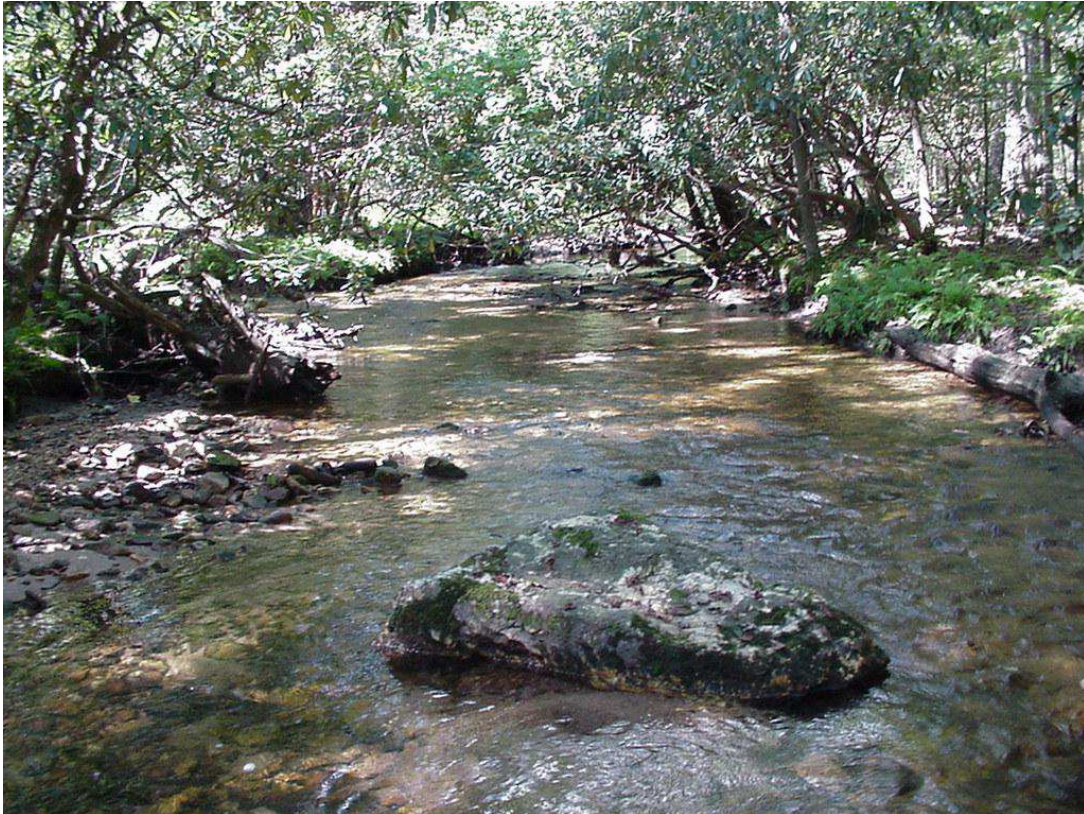
Photo C.17 Mountain Creek (MN3-15.10)

MN3-15.10 was located approximately 120 meters upstream of the Rt. 233 crossing in the Michaux Road vicinity. Land use in the reach area was dominated by forest with a road running along the right bank (20 meters from edge of water). Consequently, human disturbance was not evident. Evidence of erosive high flows was noted, as bank stabilities were suboptimal and sediment deposition was minimal. Substrate was optimal and dominated by cobble, root wads, and snags. The stream at this site was approximately 3.5 meters in width and 0.4 meters in depth. Data analysis indicated that MN3-15.10 had excellent habitat and a slightly impaired benthic macroinvertebrate community. See Photo C.17.

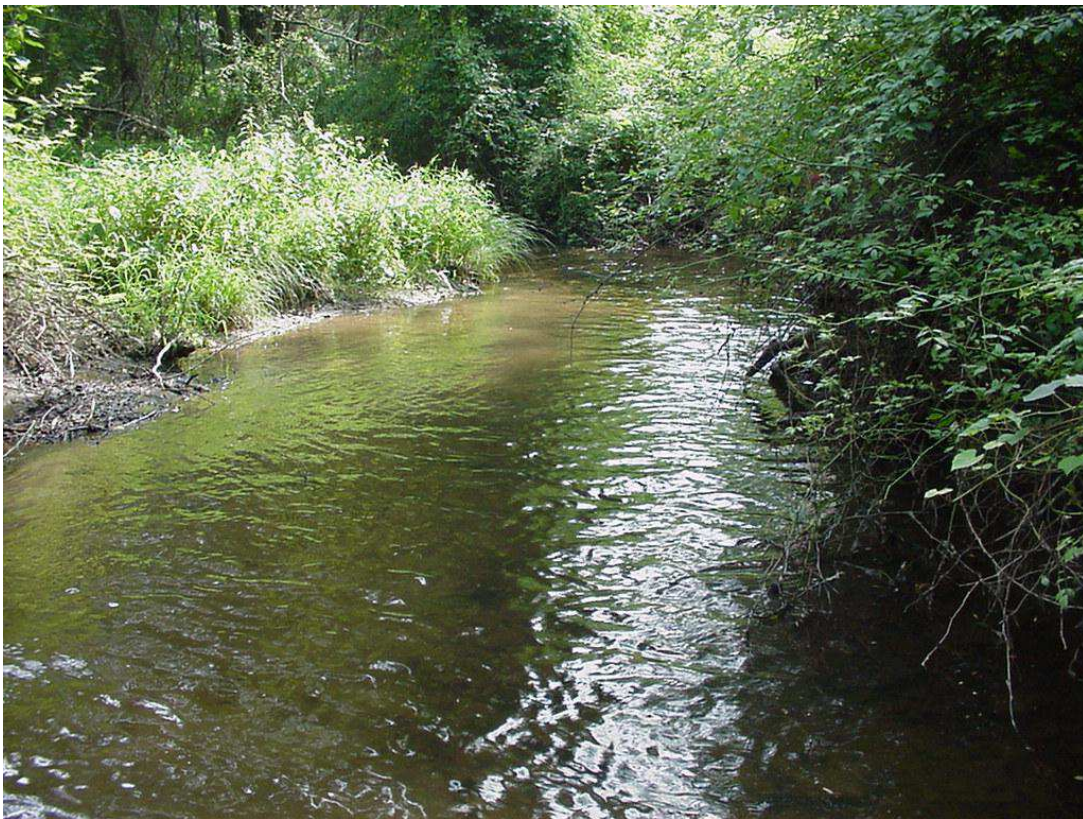
Photo C.18 Old Town Run (OR1-0.51)

OR1-0.51 was located approximately 30 meters downstream of the Tangers Road crossing and serves as the low-gradient reference site. Land use was dominated by forest, and suboptimal riparian zones were present. Banks were moderately stable as only infrequent erosion was noted. Sediment deposition was not evident, and the substrate was optimal. Sampled substrate was dominated by cobble, root wads, and sand. The stream at this site was approximately 2 meters in width and 0.2 meters in depth. Data analysis indicated that OR1-0.51 had excellent habitat and a nonimpaired benthic macroinvertebrate community. See Photo C.18.

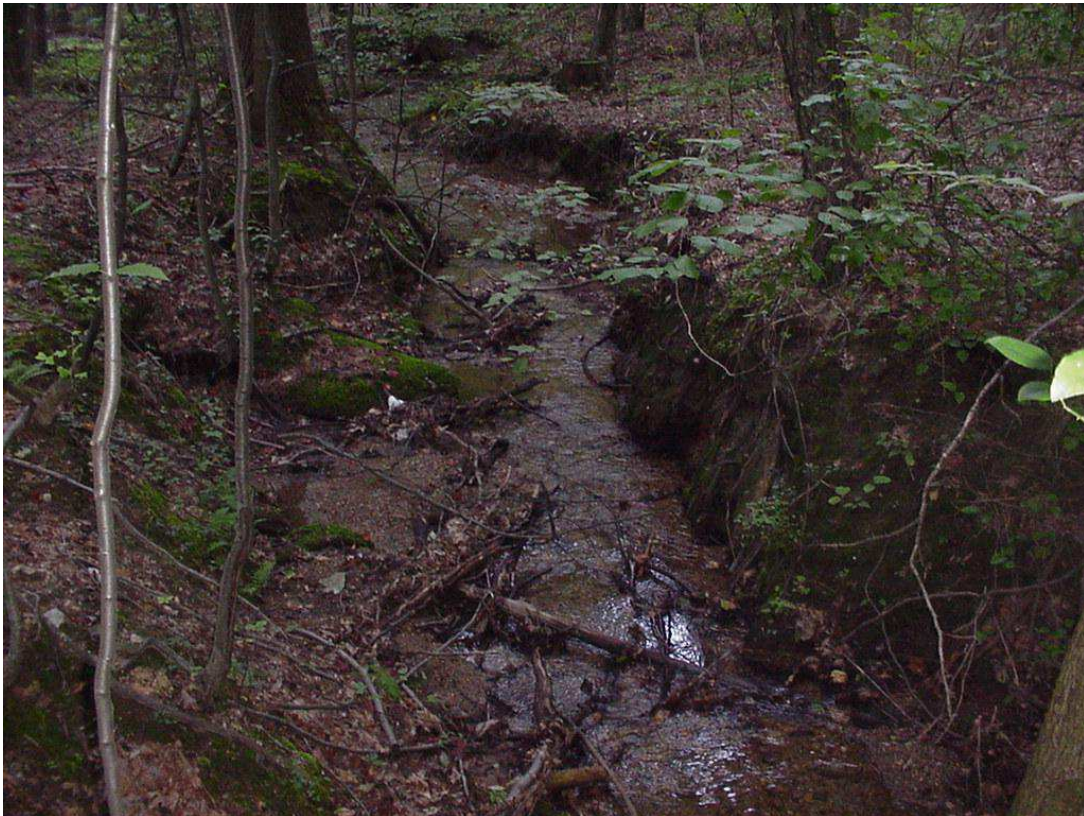
Photo C.19 Old Town Run (OR2-2.74)

OR2-2.74 was located approximately 30 meters downstream of Whiskey Spring Road crossing. This tributary was dominated by forest and abutted by steep terrain. Substrate was optimal and dominated by cobble, snags, and root wads. Some sediment deposition and marginal bank stability was observed. Vegetative protection of the streambanks was poor. Approximately 90% of the reach was riffle with the remainder as pool. The stream at this site was approximately 1 meter in width and 0.05 meters in depth. Data analysis indicated that OR2-2.74 had partially supporting habitat and a moderately impaired benthic macroinvertebrate community. See Photo C.19.
