Yellow Breeches Creek Watershed Assessment

Cumberland, York and Adams Counties, Pennsylvania

April 2005

HRG Project No. 0243.180

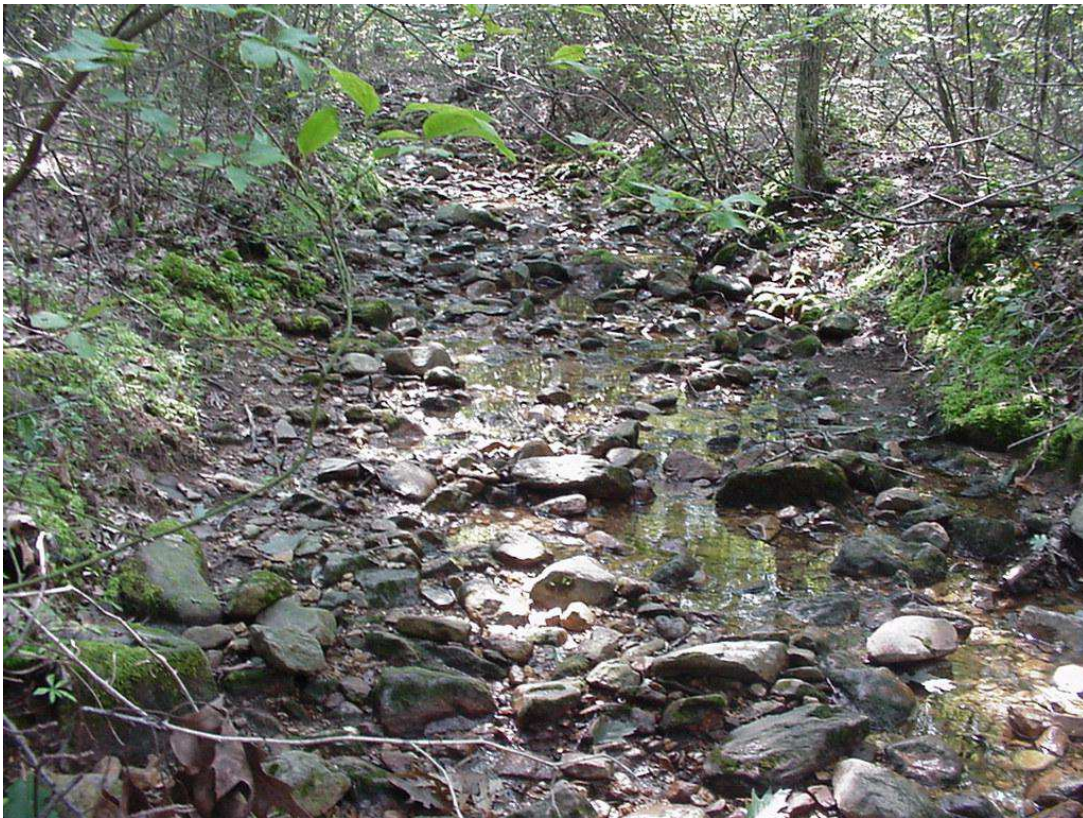
Photo C.20 Peach Orchard Hollow (PH1-2.10)

Peach Orchard Hollow - One site was chosen on Peach Orchard Hollow (PH1-2.10) and was classified as high-gradient. PH1-2.10 was located approximately 60 meters downstream of the Peach Orchard Hollow Road crossing. Surrounding land uses were dominated by forested land use. Bank stability was suboptimal, and no evidence of sediment deposition was noted. Substrate was optimal and was dominated by cobble. Despite lying within a forested area, no large woody debris and only small amounts of detritus were observed. The flow at this site was extremely slow, and the stream appears to submerge underground approximately 100 meters downstream of the bottom of the reach. The stream at this site was approximately 0.5 meters in width and 0.2 meters in depth. Data analysis indicated that PH1-2.10 had supporting habitat and a moderately impaired benthic macroinvertebrate community. See Photo C.20.

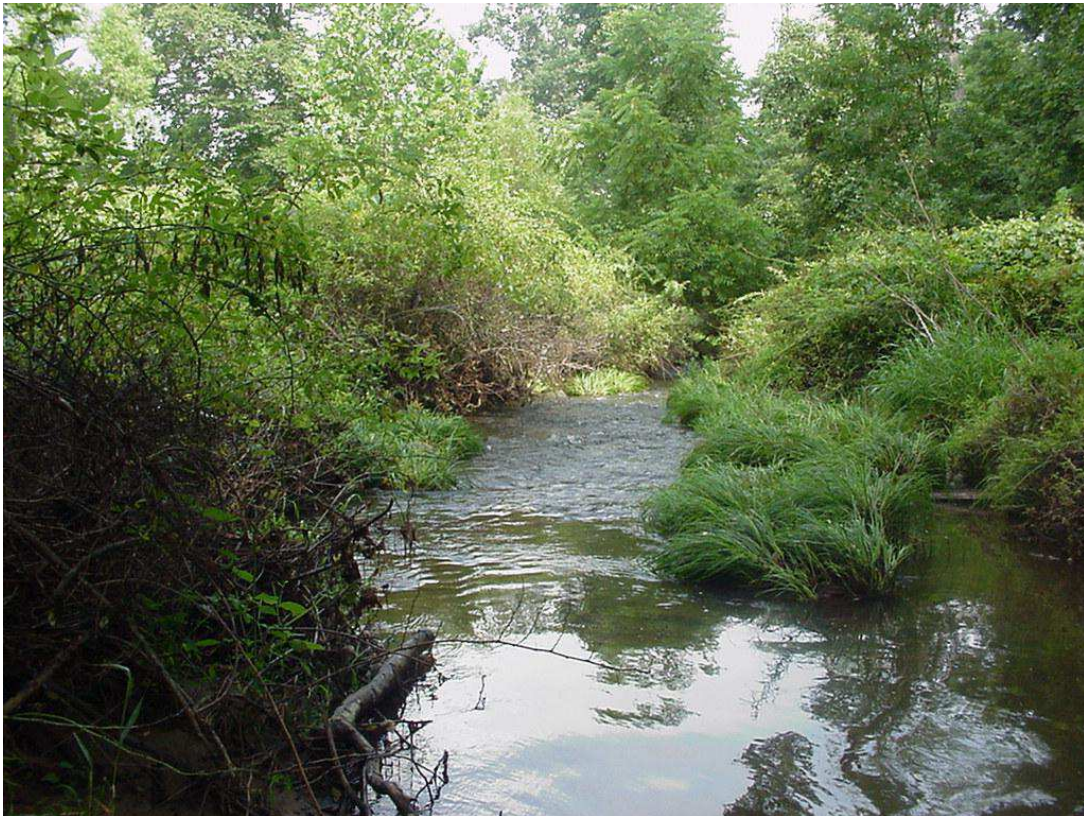
Photo C.21 Pippins Run (PR1-0.17)

Pippins Run - One site was chosen on Pippins Run (PR1-0.17) and was classified as high-gradient. PR1-0.17 was located approximately 45 meters downstream of the Lewisberry Road crossing. Surrounding land uses were dominated by fallowed pastureland. The reach was largely dominated by riffle and cobble. Sediment deposition was not evident, and bank stabilities were good. Blacknose dace were abundant at the site. The stream at this site was approximately 2 meters in width and 0.2 meters in depth. Data analysis indicated that PR1-0.17 had excellent habitat and a nonimpaired benthic macroinvertebrate community. See Photo C.21.

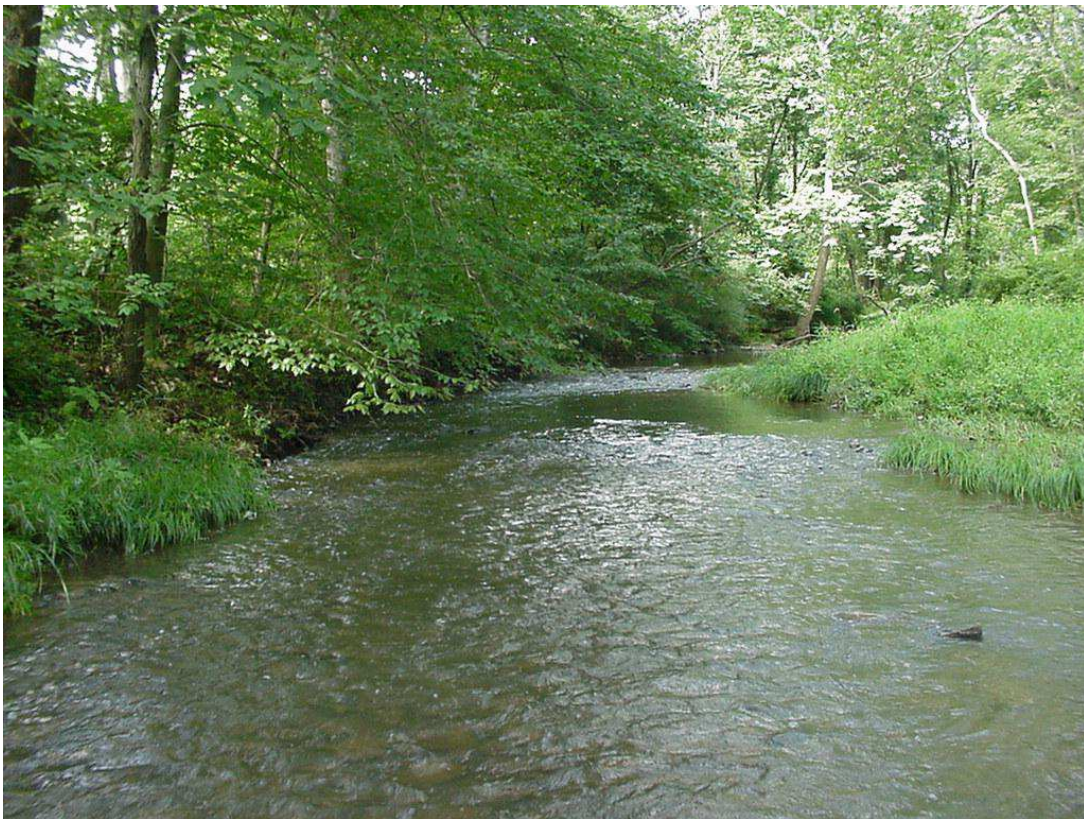
Photo C.22 Stony Run (SR1-0.43)

SR1-0.43 was located approximately 30 meters upstream of the Grantham Road crossing. Surrounding land use was forested, and no evidence of nonpoint source pollution was noted. The riparian zone on the left bank was intact. Right bank stability was notably lower than the left bank, largely due to the presence of a road along the right bank. Overall, the site exhibited no signs of sedimentation. Substrate was found to be suboptimal and largely consisted of cobble. The reach was dominated by riffle. The stream at this site was approximately 6 meters in width and 0.60 meters in depth. Data analysis indicated that SR1-0.43 had excellent habitat and a slightly impaired benthic macroinvertebrate community. See Photo C.22.

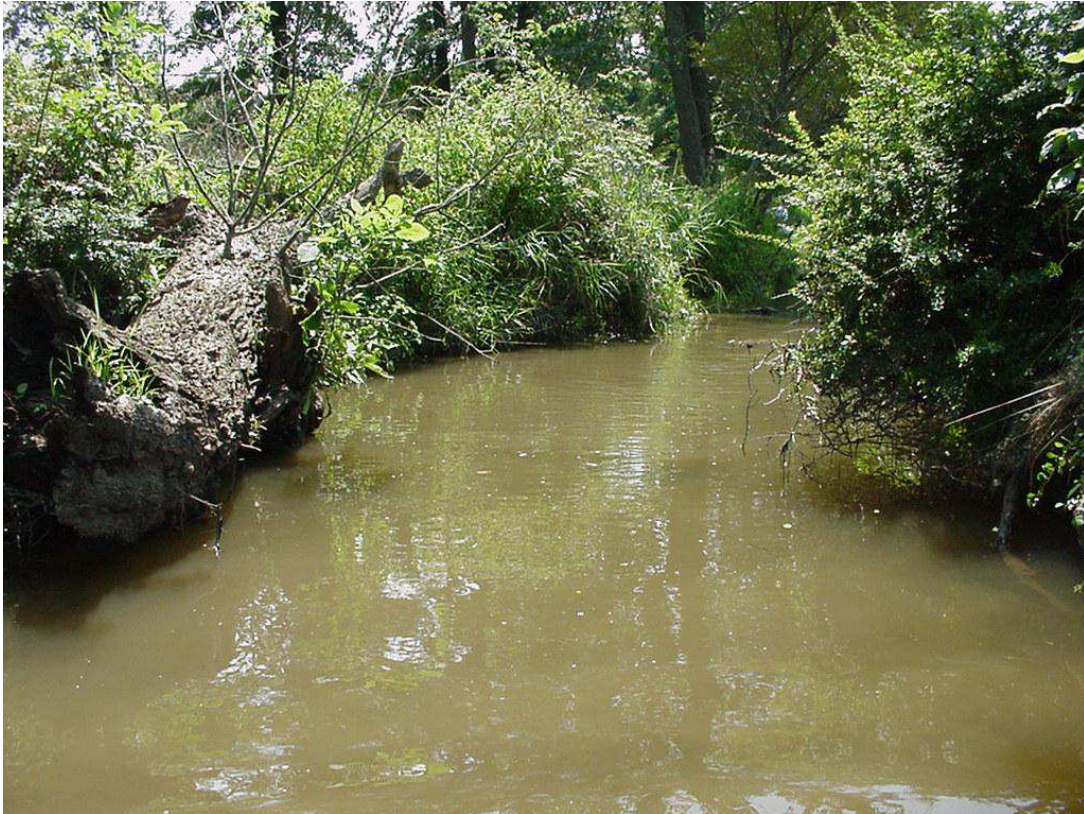
Photo C.23 Stony Run (SR2-5.09)

SR2-5.09 was located approximately 30 meters downstream of the Old York Road crossing. Land use within the reach was agricultural and nonpoint source pollution was evident. The riparian zone was suboptimal and dominated by grasses and herbaceous vegetation. Bank stabilities were marginal, with rather significant undercutting and sedimentation. Substrate was poor and consisted of sand, cobble, snags, macrophytes, and root wads. The stream at this site was approximately 3 meters in width and 0.75 meters in depth. Data analysis indicated that SR2-5.09 had supporting habitat and a slightly impaired benthic macroinvertebrate community. See Photo C.23.

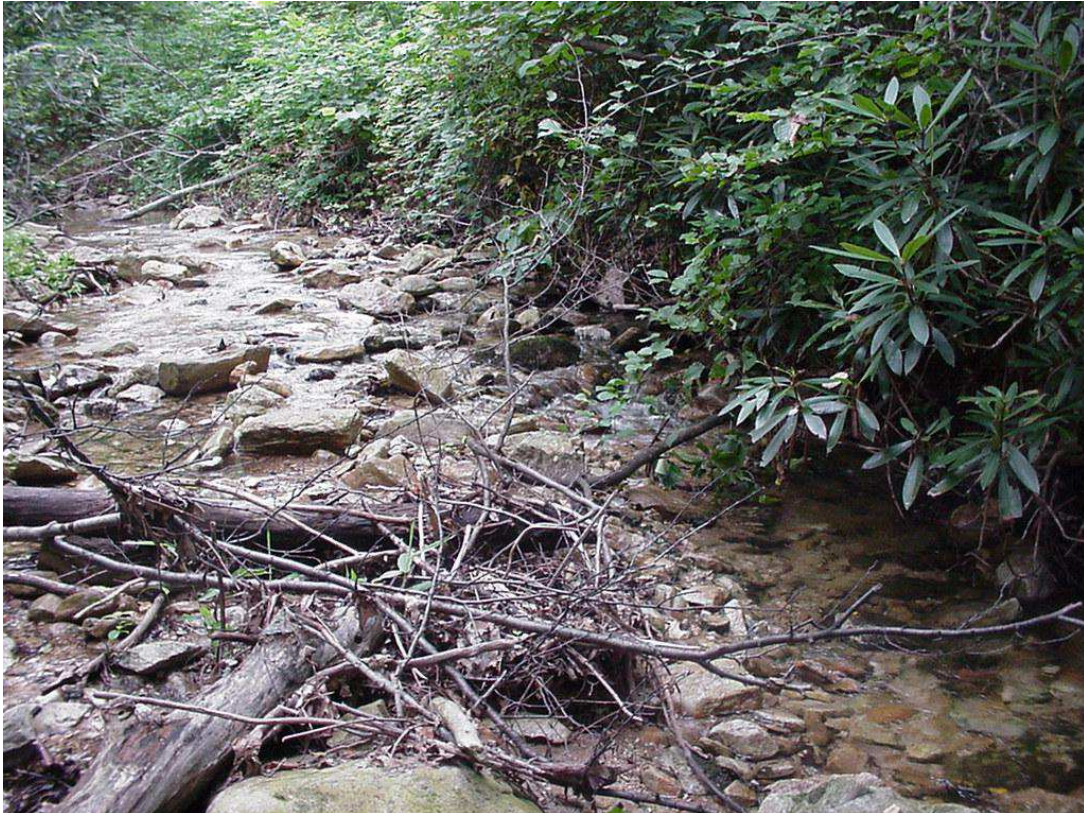
Photo C.24 Sthromes Hollow (STH1-1.72)

Sthromes Hollow - One site was chosen on Sthromes Hollow (STH1-1.72) and was classified as high-gradient. STH1-1.72 was located approximately 60 meters upstream of Sand Hill Road crossing. Land use in the vicinity was forested, and some nonpoint source pollution was noted. Riparian zones were suboptimal, and vegetative protection was only marginal. Bank stability for both banks was poor, but little increased sedimentation was noted. Substrate was suboptimal and consisted of cobble and snags. The site was dominated by riffles. The stream at this site was approximately 2.5 meters in width and 0.42 meters in depth. Data analysis indicated that STH1-1.72 had partially supporting habitat and a moderately impaired benthic macroinvertebrate community. See Photo C.24.

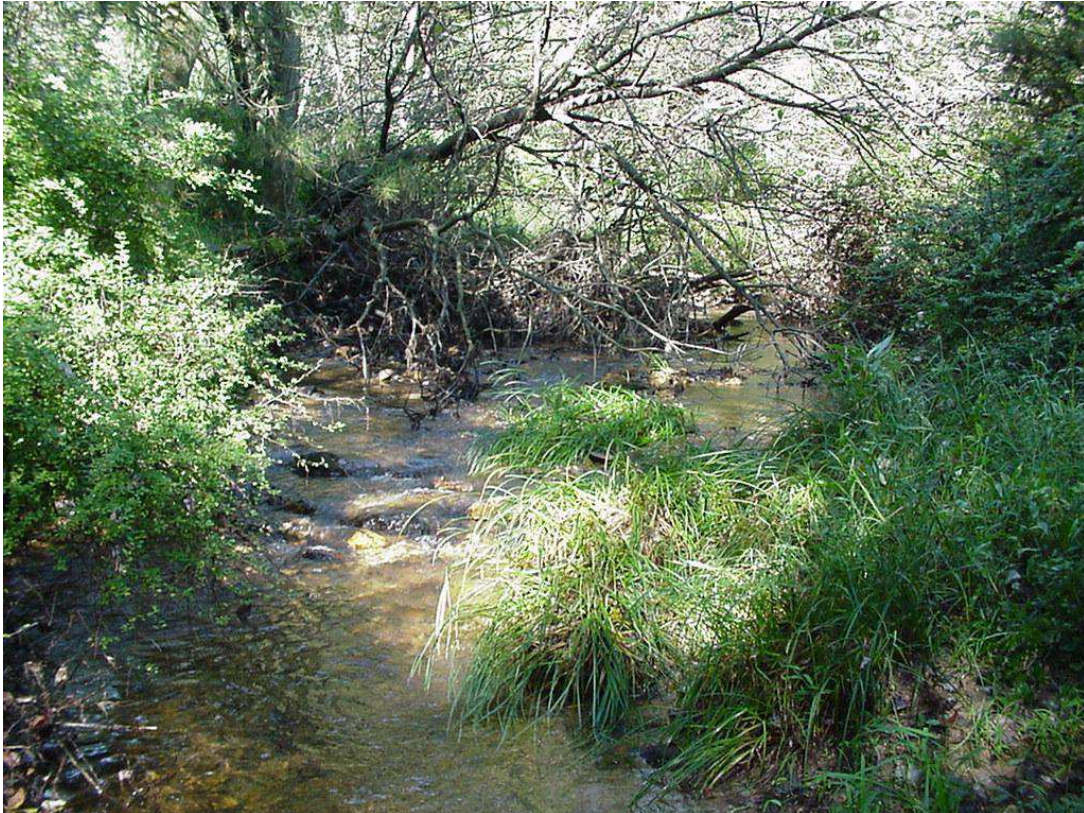
Photo C.25 Toms Run (TR1-0.85)

Tom's Run - One site was chosen on Tom's Run (TR1-0.85), was classified as high-gradient, and serves as the high-gradient tributary reference site. TR1-0.85 was located approximately 60 meters downstream of the Rt. 233 crossing. Surrounding land use consisted of pine forest, and the riparian zone was optimal, with the exception of the presence of a road along the right bank. Bank stability was suboptimal with minimal sedimentation. Vegetative protection on the right bank was greater than the left, but only marginally. Substrate was optimal and was dominated by cobble and snags. The stream at this site was approximately 2.5 meters in width and 0.3 meters in depth. Data analysis indicated that TR1-0.85 had excellent habitat and a nonimpaired benthic macroinvertebrate community. See Photo C.25.

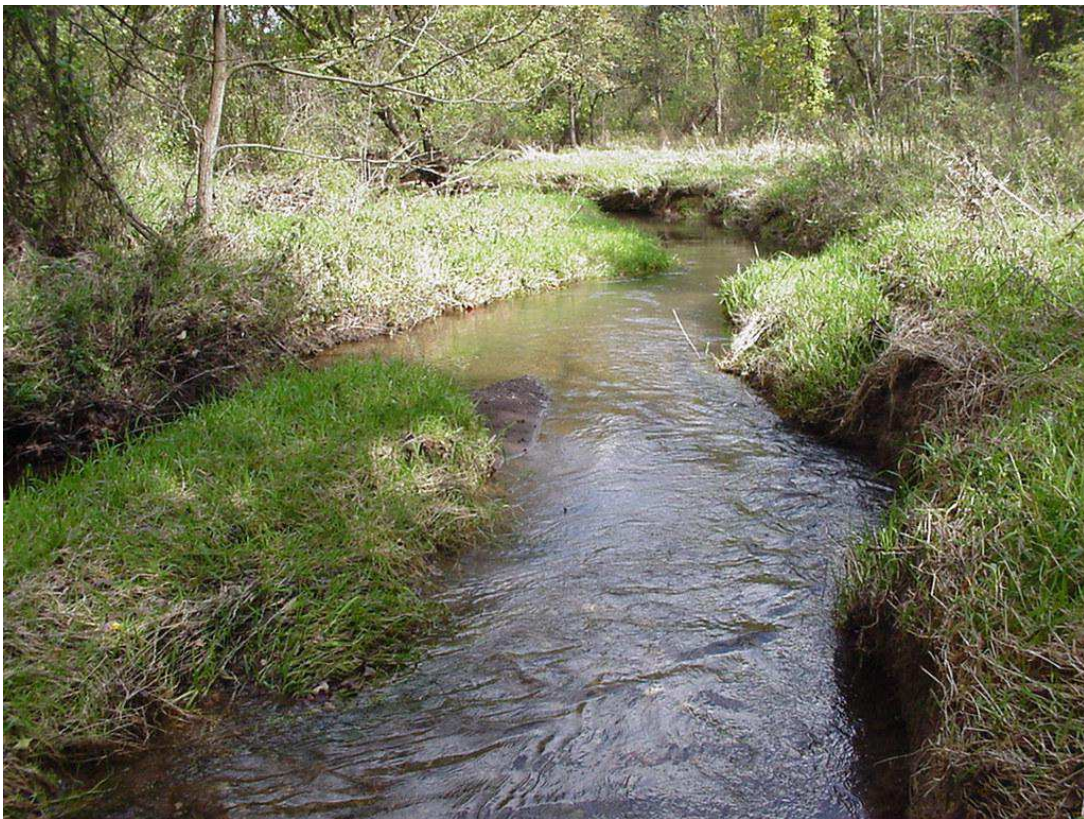
Photo C.26 Unnamed Tributary to Yellow Breeches Creek (UNT1-0.11)

Unnamed Tributary to Yellow Breeches Creek- One site was chosen on an unnamed tributary to Yellow Breeches Creek (UNT1-0.11) and was classified as low-gradient. UNT1-0.11 was located approximately 600 meters upstream of the Lisburn Road crossing. Forest was located along the right bank, and residential land use was located along the left bank. However, disturbance on both banks was minimal and the riparian zone was greater than 18 meters in width. The reach was dominated by run. Some of the pools that were present were deep and contained eroded and undercut banks. Stability was poor for the left bank and marginal for the right. Vegetative cover along the banks was suboptimal. Sediment deposition was moderate. Substrate appeared marginal and consisted largely of cobble, snags, and vegetated banks. Evidence of high flows (highwater mark of 2 meters) was noted. The stream at this site was approximately 3 meters in width and 0.3 meters in depth. Data analysis indicated that UNT1-0.11 had supporting habitat and a slightly impaired benthic macroinvertebrate community. See Photo C.26.

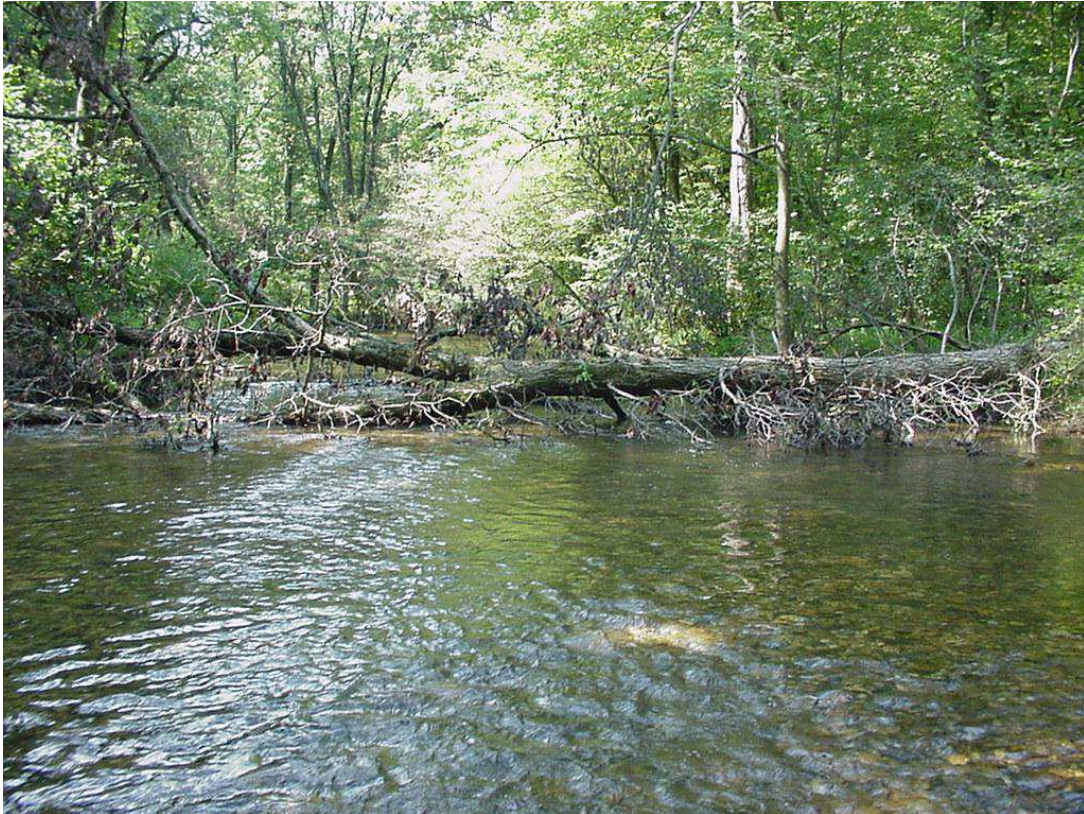
Photo C.28 Yellow Breeches Creek (YB2-42.48)

YB2-42.48 was located approximately 90 meters upstream of Enck’s Mill Road crossing. The majority of the surrounding land use was forested. Bank stability and vegetative protection for each bank was excellent. Sediment deposition was minimal, and large woody debris was present throughout the reach. The reach was equally distributed between riffle and run. The substrate was largely dominated by gravel, with some cobble and organic detritus. The stream at this site was approximately 13 meters in width and 0.3 meters in depth. Data analysis indicated that YB2-42.48 had excellent habitat and a slightly impaired benthic macroinvertebrate community. See Photo C.28.

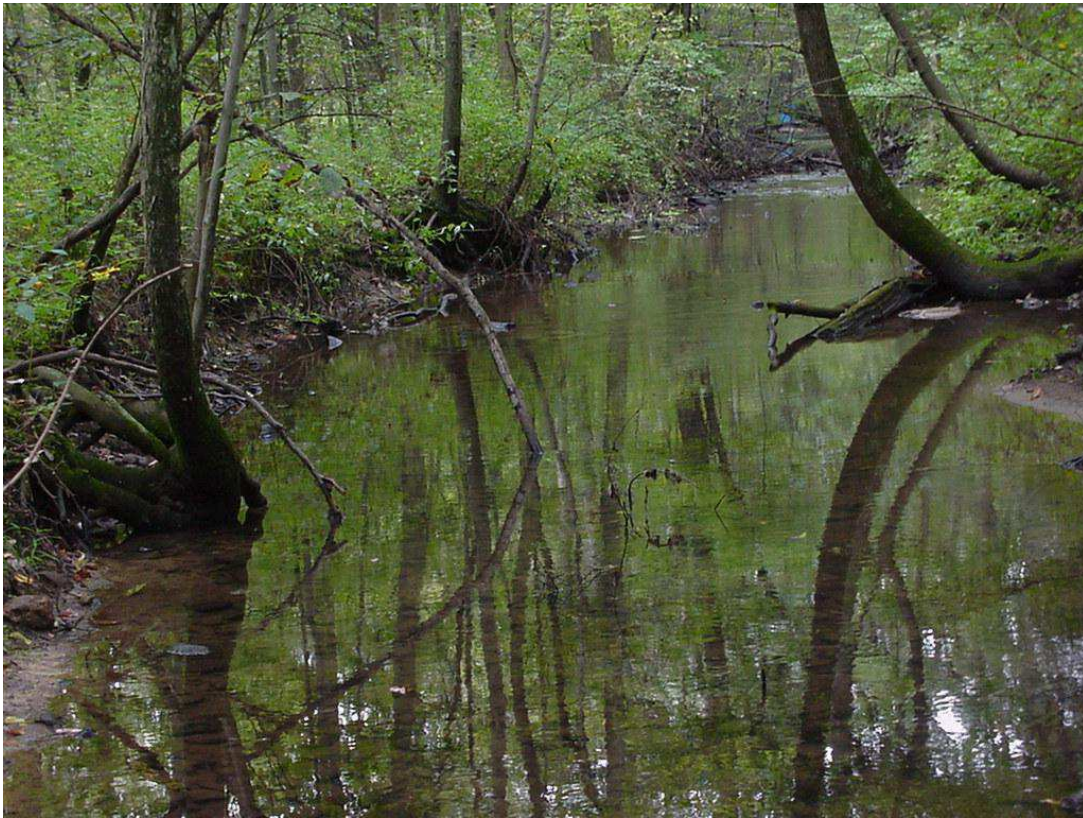
Photo C.29 Yellow Breeches Creek (YB3-47.21)

YB3-47.21 was located approximately 30 meters upstream of Hays Grove Road crossing. Surrounding land use was dominated by forest with lesser amounts of field and pasture. The riparian zone was suboptimal for the left bank and only marginal for the right due to pastureland. Vegetative bank protection and bank stability were suboptimal. Sediment deposition was moderate throughout the reach. The reach was largely dominated by run with some riffle. The substrate consisted of cobble, gravel, some sand, and detritus. The site included noticeable amounts of litter, including a tire and an empty 55-gallon plastic drum. The stream at this site was approximately 3 meters in width and 0.15 meters in depth. Data analysis indicated that YB3-47.21 had partially supporting habitat and a slightly impaired benthic macroinvertebrate community. See Photo C.29.

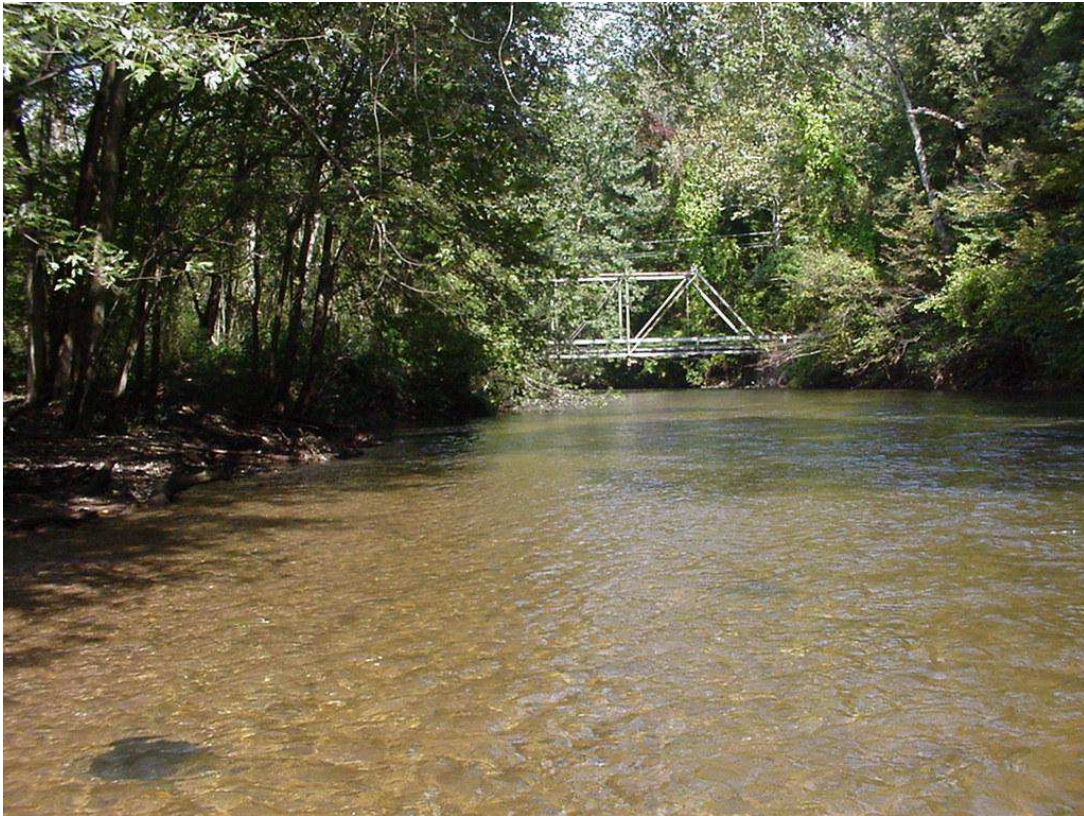
Photo C.30 Yellow Breeches Creek (YB4-10.32)

YB4-10.32 was located approximately 60 meters upstream of the Sheepford Road bridge crossing. Land use within the vicinity was mostly forested, but residential development was also present. The right bank had a moderately high slope, and the left bank consisted of floodplain. The riparian zone was marginal due to some anthropogenic influences on both banks. Vegetative bank protection was marginal for the left bank, and bank stability was poor. Both vegetative bank protection and bank stability were suboptimal for the right bank, primarily due to floodplain influences. Substrate was dominated by cobble and gravel, with some detritus and muck/mud. The majority of the reach consisted of run with some riffle, with extensive large woody debris. The stream at this site was approximately 25 meters in width and 0.30 meters in depth. Data analysis indicated that YB4-10.32 had supporting habitat and a slightly impaired benthic macroinvertebrate community. See Photo C.30.

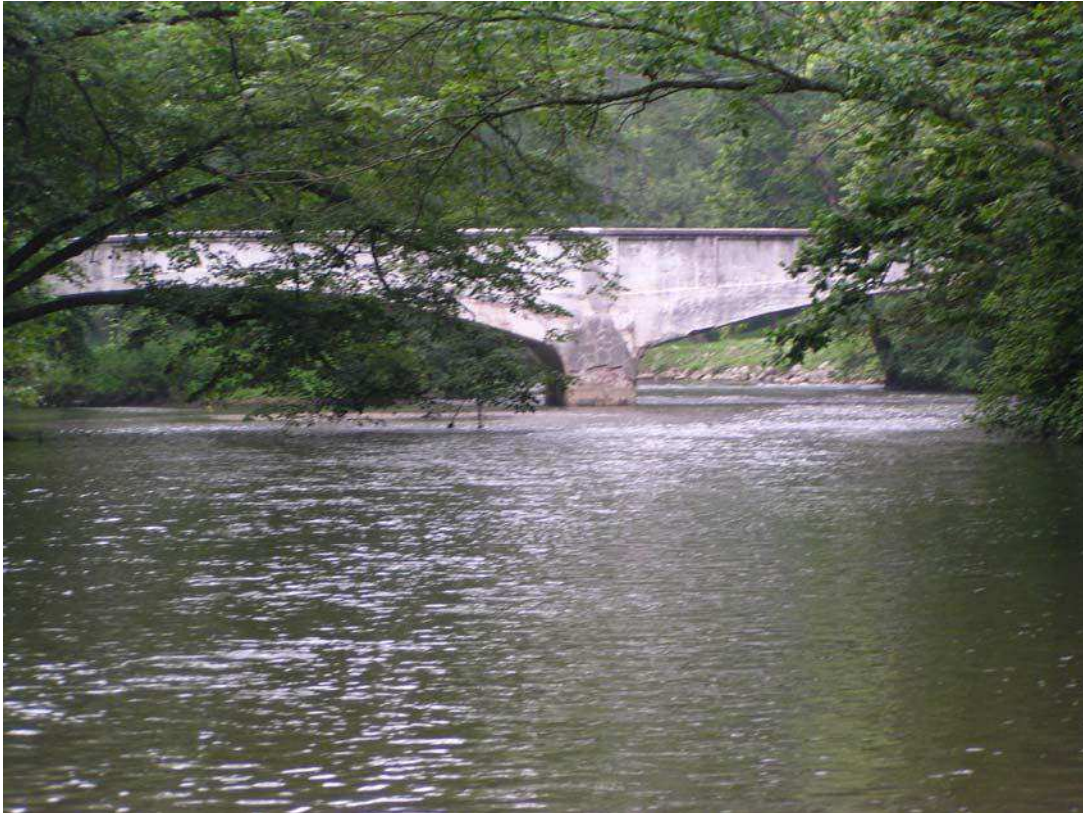
Photo C.31 Yellow Breeches Creek (YB5-15.26)

YB5-15.26 was located approximately 150 meters downstream of McCormick Road, west of Lisburn Road. Land use within the reach was a mix of forest and large-lot residential. The riparian zone on each bank was poor and influenced by the presence of a road. Bank stabilities were marginal to suboptimal while vegetative bank protection was suboptimal. Sediment deposition was moderate throughout the reach and appeared recent. Riffles made up the predominant stream morphology with some run. Substrate was dominated by cobble and gravel. The stream at this site was approximately 25 meters in width and 0.33 meters depth. Data analysis indicated that YB5-15.26 had partially supporting habitat and a slightly impaired benthic macroinvertebrate community. See Photo C.31.

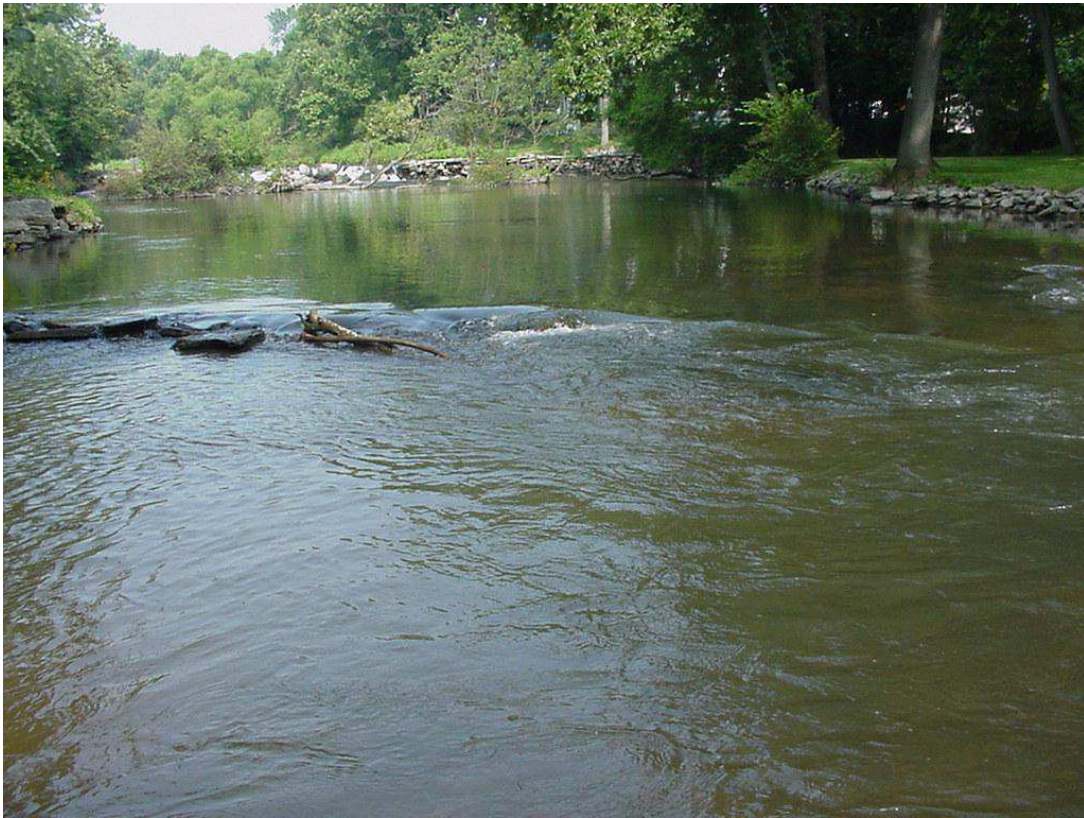
Photo C.32 Yellow Breeches Creek (YB6-24.44)

YB6-24.44 was located approximately 45 meters upstream of Creek Road/Rt. 74. Land use within the reach was dominated by residential with the presence of agricultural activities upstream. A cobble/boulder dam was present upstream of the reach. The left bank riparian zone was poor due to the presence of a road. The right bank was also poor due to residential influences. Vegetative protection on both banks was marginal, bank stability was marginal to suboptimal, and sediment deposition was evident in some locations. Substrate was dominated by cobble with some gravel. The majority of the reach consisted of riffle with some run. The stream at this site was approximately 18 meters and 0.25 meters in depth. Data analysis indicated that YB6-24.44 had supporting habitat and a nonimpaired benthic macroinvertebrate community. See Photo C.32.

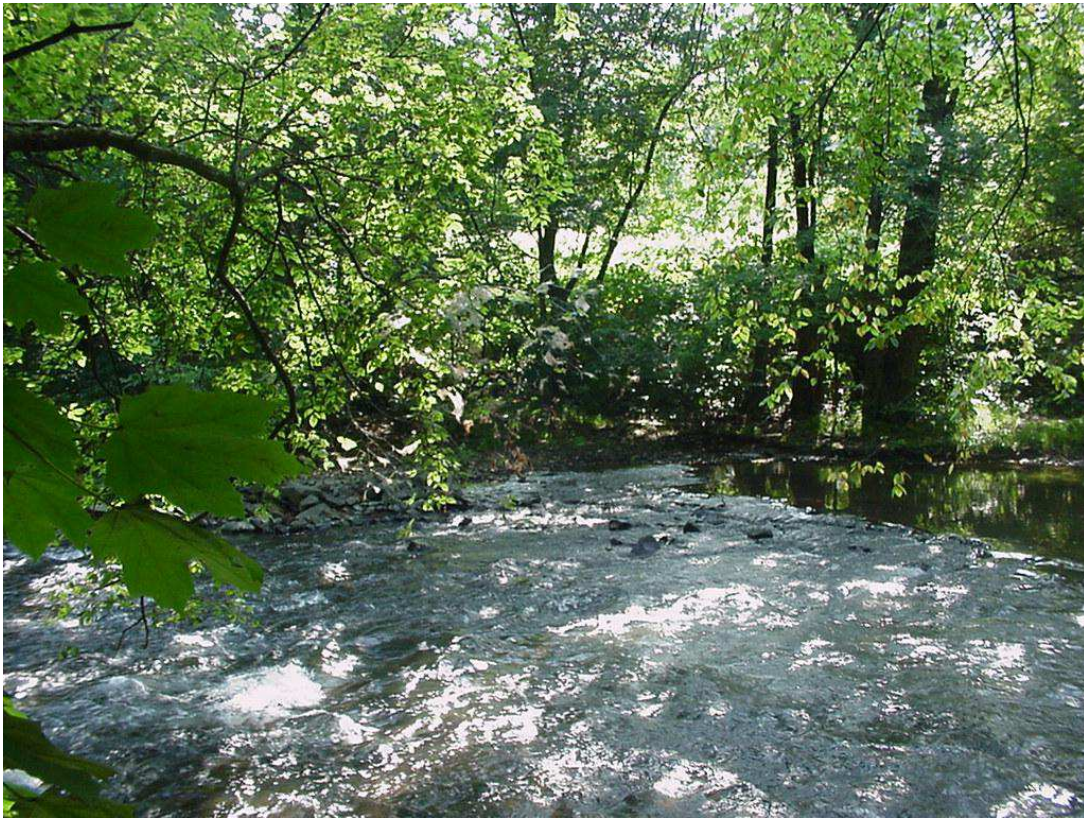
Photo C.33 Yellow Breeches Creek (YB7-29.12)

YB7-29.12 was located approximately 60 meters downstream of the Mountain Road Bridge crossing and serves as the mainstem reference site. Surrounding land use consisted of forest with some residential and agricultural uses present. The riparian zone was suboptimal because of a road along the right bank of the stream and human use along the left. Vegetative cover and bank stability were suboptimal. Sediment deposition was not readily noticeable within the reach, and several overhanging trees were present. The reach was dominated by run, with some pool and riffle. Substrate was dominated by gravel, with some cobble, boulder, sand, and detritus. Fish were abundant within the reach. The stream at this site is approximately 14 meters in width and 1.5 meters in width. Data analysis indicated that YB7-29.12 had excellent habitat and a nonimpaired benthic macroinvertebrate community. See Photo C.33.

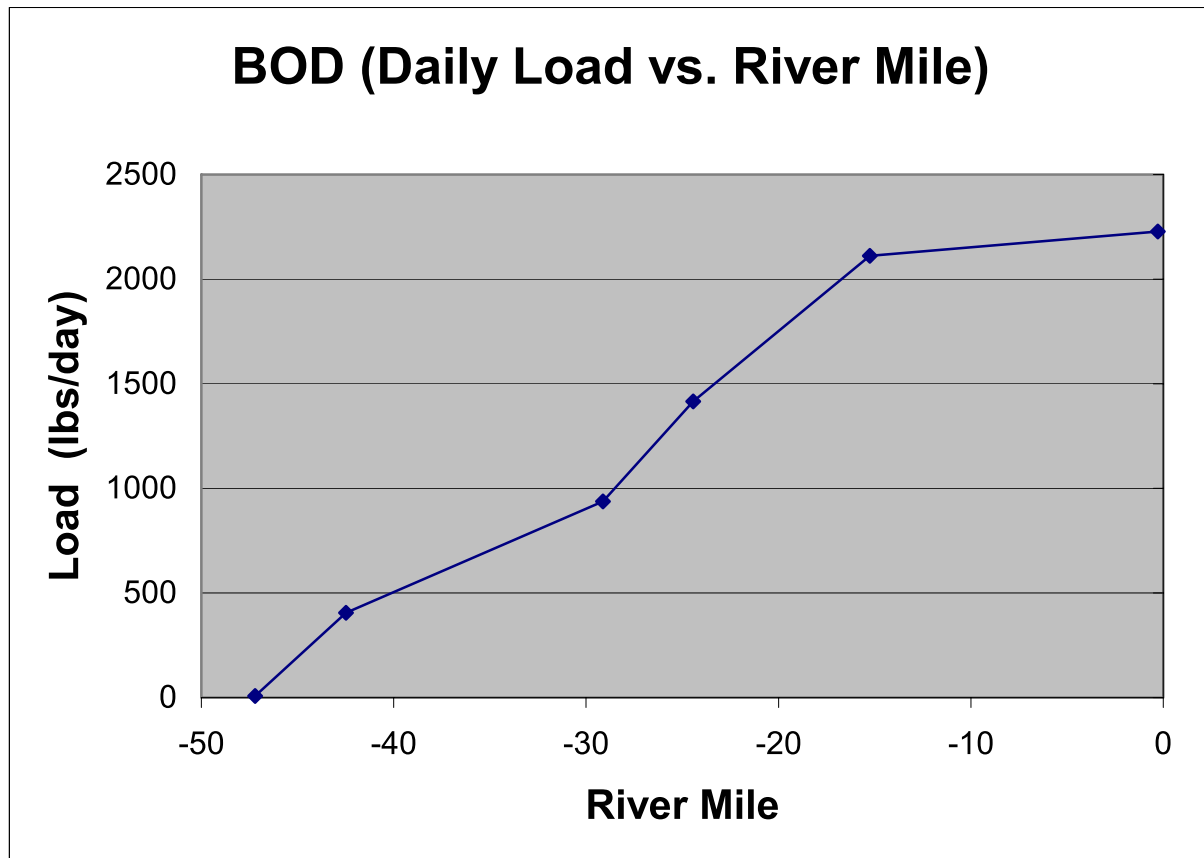
Graph D.2 Biological Oxygen Demand

Biological oxygen demand ranged in concentration from 2 to 7 mg/liter for all monitoring sites. CSR1-0.82 exceeded the standard, 5 mg/l, as shown in Table D.1. Daily loads and yields were calculated for all monitoring sites. Load versus river mile was plotted as shown in Graph D.2, indicating an increase in daily load as the Yellow Breeches Creek flows toward the mouth. The highest yields recorded were at Cedar Run (CR1-0.28), Pippins Run (PR1-0.17), Stony Run (SR3-1.06), and Unnamed Tributary (UNT1-0.11), indicating increased oxygen consumption as a result of surrounding urban influences. The lowest yields were recorded at Little Dogwood Run (LD1-0.97) and Peach Orchard Hollow (PH1-2.10), indicating less urban influence in these primarily rural areas. See Table D.4 for biological oxygen demand data.

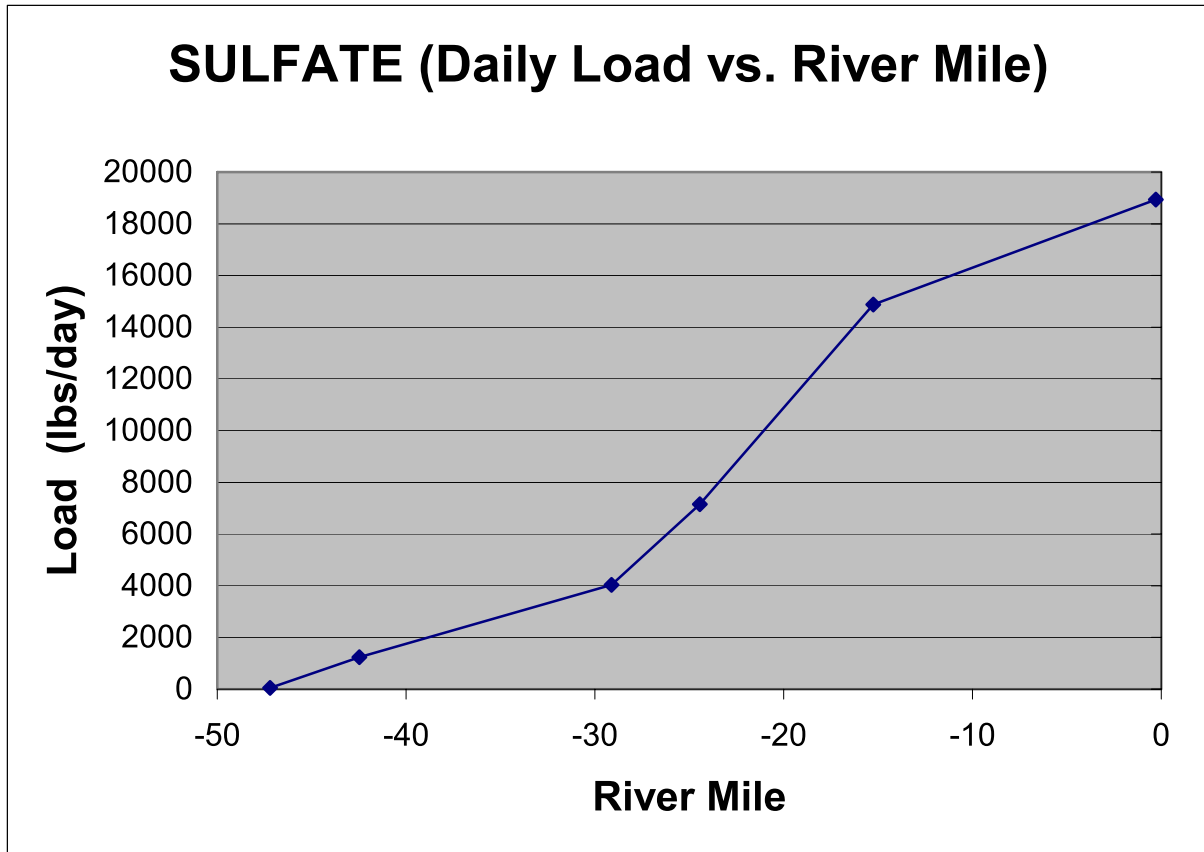
Graph D.3 Sulfate

Sulfates ranged from 3.4 to 27.7 mg/liter in concentration for all monitoring sites. Daily loads and yields were calculated for all monitoring sites. Load versus river mile was plotted as shown in Graph D.3, indicating an increase in daily load as the Yellow Breeches Creek flows toward the mouth. The highest yields were recorded at Unnamed Tributary (UNT1-0.11) and Cedar Run (CR1-0.28 and CR4-0.39). The Unnamed Tributary (UNT1-0.11) and Cedar Run (CR1-0.28 and CR4-0.39) are downstream from multiple industrial and municipal sites, possibly discharging sulfur-containing compounds into the stream. A yield of zero was recorded for multiple monitoring sites located in primarily rural areas. Values from all monitoring sites were below the Pennsylvania state standard of 250 mg/liter. See Table D.4 for sulfates data.

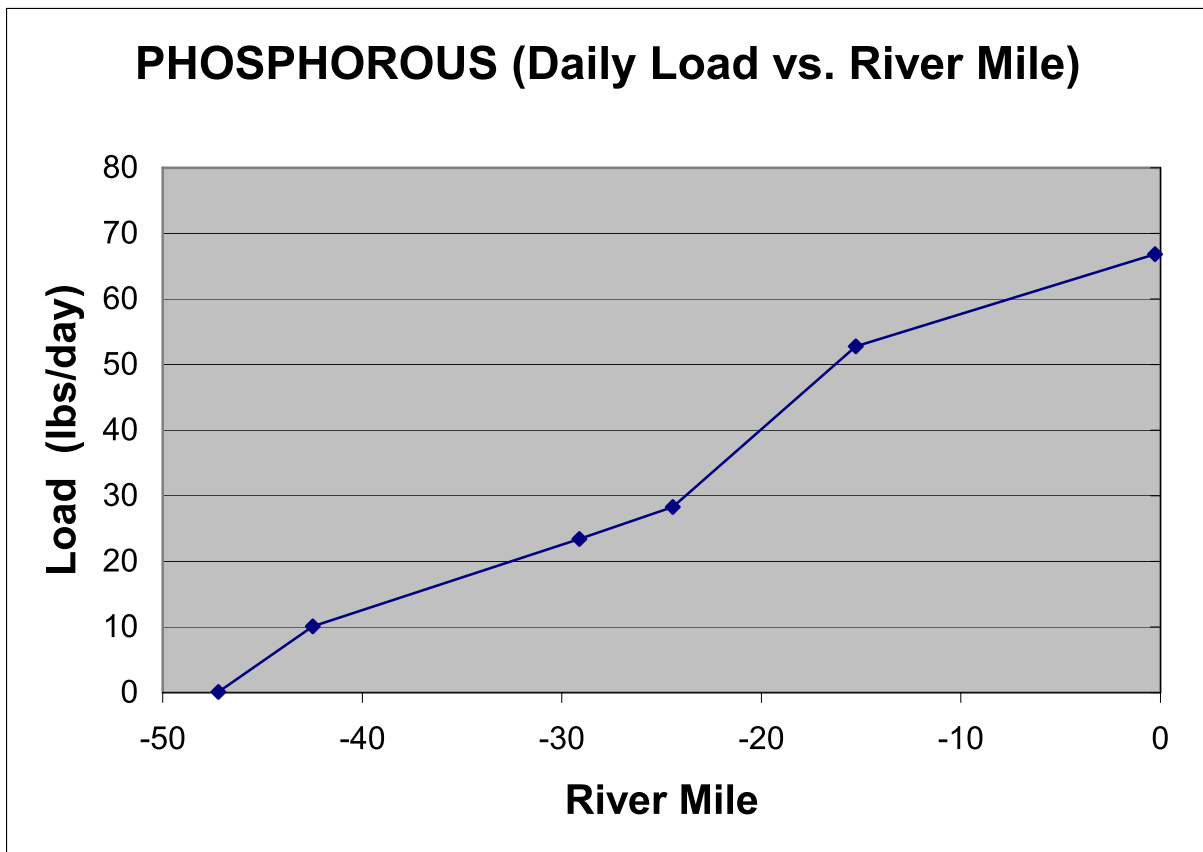
Graph D.5 Phosphorous

Total phosphorous ranged from less than 0.02 to 0.11 mg/liter for all monitoring sites. There are no Pennsylvania state standards for phosphorous. SRBC uses a value of 0.1 mg/liter for determining potential impacts to aquatic life uses. The phosphorous concentrations were all below the standard as shown in Table D.1, with the exception of Dogwood Run (DR1-0.70 and DR2-1.85). Daily loads and yields were calculated for all monitoring sites. Load versus river mile was plotted as shown in Graph D.5, indicating an increase in daily load as the Yellow Breeches Creek flows toward the mouth. The highest yields were recorded at Dogwood Run (DR1-0.70), Pippins Run (PR1-0.17), and Stony Run (SR1-0.43). These monitoring sites are subject to upstream agricultural influences where increased runoff washes phosphates from farm soils into the stream, as a result of suboptimal to poor vegetative protection and riparian buffers. A yield of zero was recorded at Little Dogwood Run (LD1-0.97) and Peach Orchard Hollow (PH1-2.10), located primarily in areas with better vegetative protection. See Table D.5 for phosphorous data.
